Moisture monitoring of mass timber building - study of condition variation and building environment design

ABSTRACT:

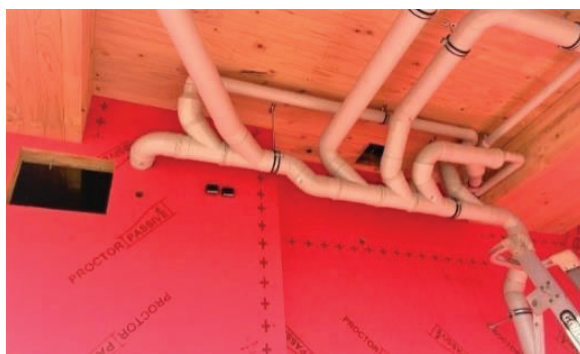
Figure 2: Sensor location close to plumbing areas on external face of the panel.

Figure 2, were installed on the external side of the CLT wall panel within the cladding cavity. The higher RH values recorded during the construction phase dropped once the cladding was installed and building construction progressed. MC recorded at both sides of the wall panel stayed around 15% pre and post construction; however, the initial MC sensor readings for the external side of the panel were higher, at around 17% (Figure 3 (a) and Figure 4 (a)).

Figure 2), leading to minimal exposure to moisture during construction (Figure 3 (b) and Figure 4 (b)), thus the calculated MGI was very low. Construction planning and the implementation of effective moisture safety protocols during construction prevent moisture gain and further complications during and after construction [9, 18]. Design consideration and further mechanisms, such as roof installation, semi-protected overhang sections, WRB applied on external face of CLT and minimum storage of material on construction site to prevent moisture exposure are equally important [10, 11]. For this case study specifically, the application of an external membrane, and the design strategy to protect the exposed CLT panel in this location of the building helped minimise moisture gain and mould growth. The comparison between the sensor recorded MC and the calculated MC using WUFI modelling is shown in Figure 3 (c).

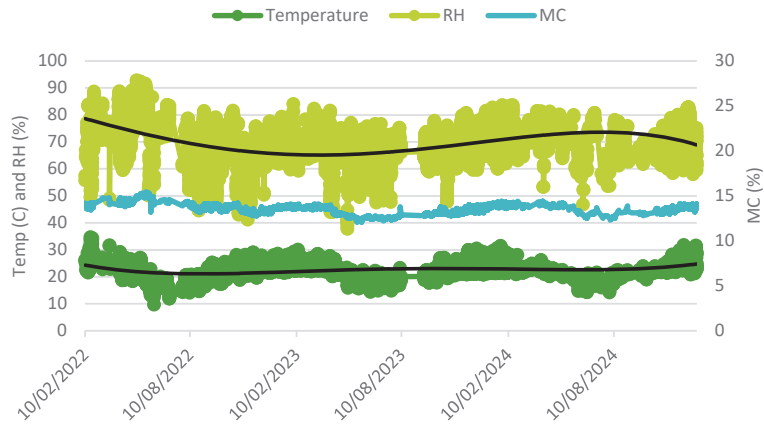
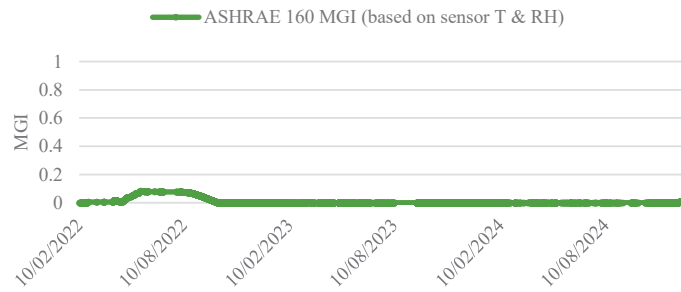
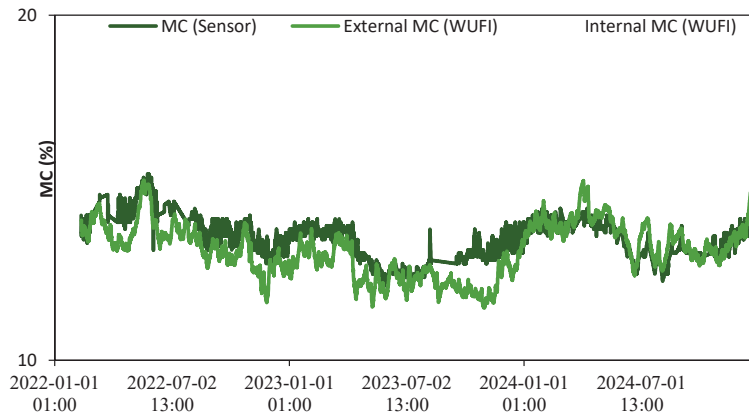
The data collected from the sensor reading at the internal 20 mm depth of the panel is shown in Figure 3 (a).

Figure 3: (a) Sensor recorded temperature, relative humidity and MC; (b) calculated MGI from the sensor data; and (c) comparison between measured and calculated MC values for the sensor located near the plumbing and reading the internal side of the panel at 20 mm depth.

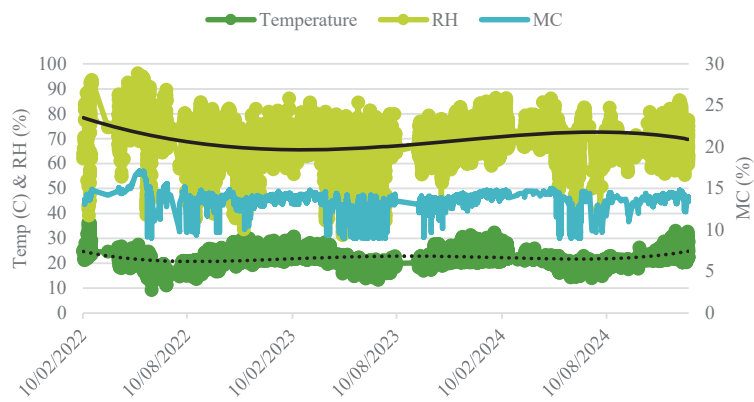
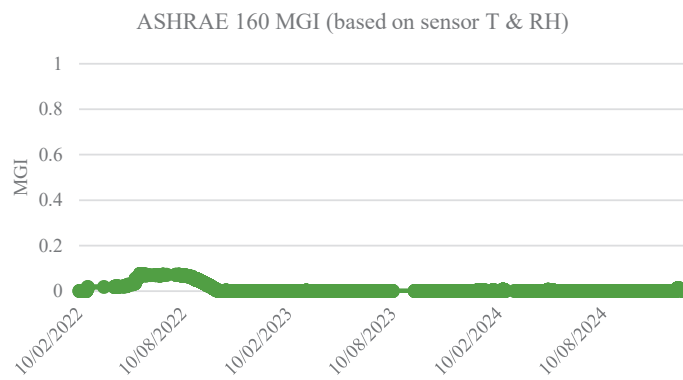
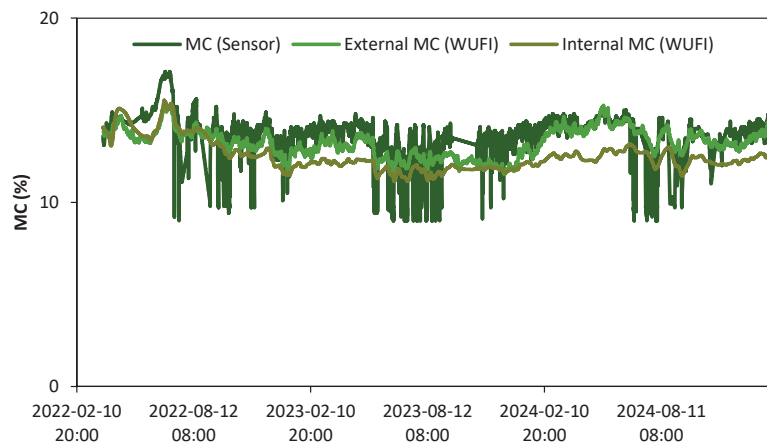
The data collected from the sensor in the same location but recording values at the 20 mm depth from the outside face of the panel is shown in Figure 4. Similar to the environmental conditions recorded by the internal reading sensor, the measured values showed a slightly higher MGI during the pre-construction phase, likely due to higher RH exposure. Figure 4 (c) shows that the WUFI predicted MC provides a good representation of actual MC including the high and low peaks recorded by the sensors.

Figure 4: (a) Sensor recorded temperature, relative humidity and MC; (b) calculated MGI from the sensor data; and (c) comparison between measured and calculated MC values for the sensor located near the plumbing and reading the external side of the panel at 20 mm depth.

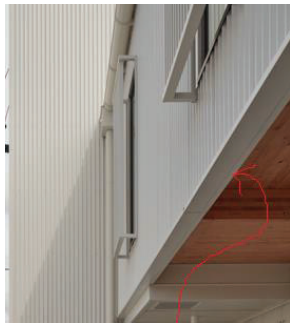
Figure 5: Exposed overhang section of the floor panel.

Figure 6 and Figure 7 present the recorded sensor data for the floor panel of an overhang section of the building which is exposed to external environmental conditions (Figure 5). It can be seen that there was a spike in MC

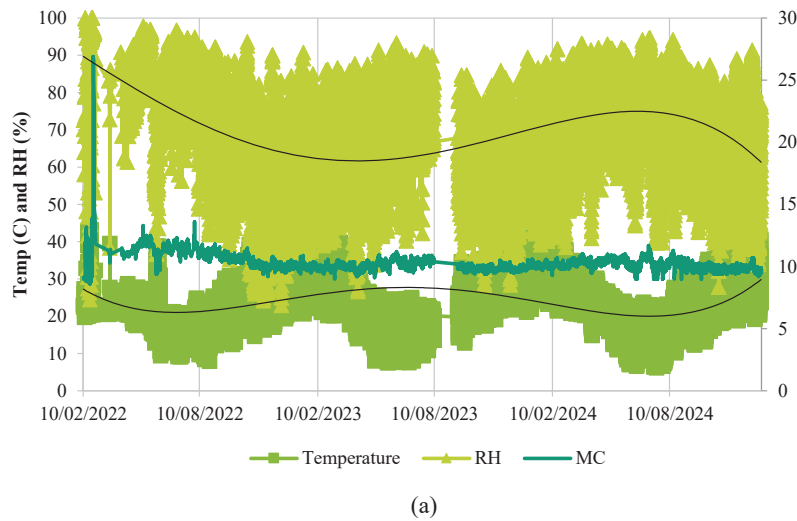
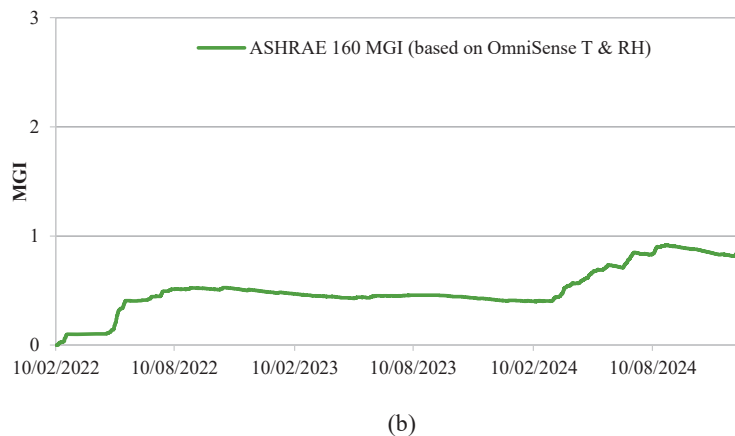
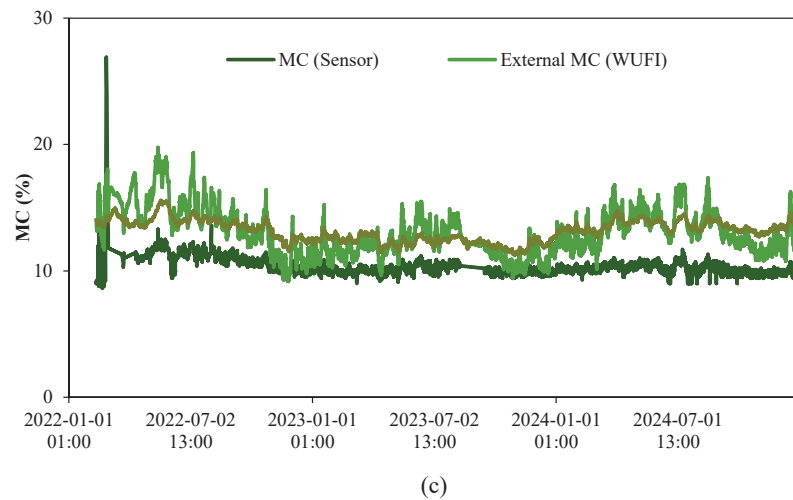
recording for both reading depths during construction, with MC values reaching above 20%. However, the MC dropped to around 10% for internal reading of the floor, as shown in Figure 6 (a). The MC values for the external side of the panel, which remained exposed to the environmental conditions, were higher, at around 15%, as shown in Figure 7 (a). The MGI calculation for both panel sides, based on RH and temperature data from sensor recording, did not show any high-risk values; however, it is recommended to use the outdoor weather data for calculating the MGI of the external, exposed face of the panel in the future. The location of sensors being installed in the interior condition of the building, due to limitation for not exposing sensors, could have led to moderated values for MGI calculations.

Figure 6: (a) Sensor recorded temperature, relative humidity and MC; (b) calculated MGI from the sensor data; and (c) comparison between measured and calculated MC values for the sensor located on the exposed floor panel and reading the internal side of the panel at 20 mm depth

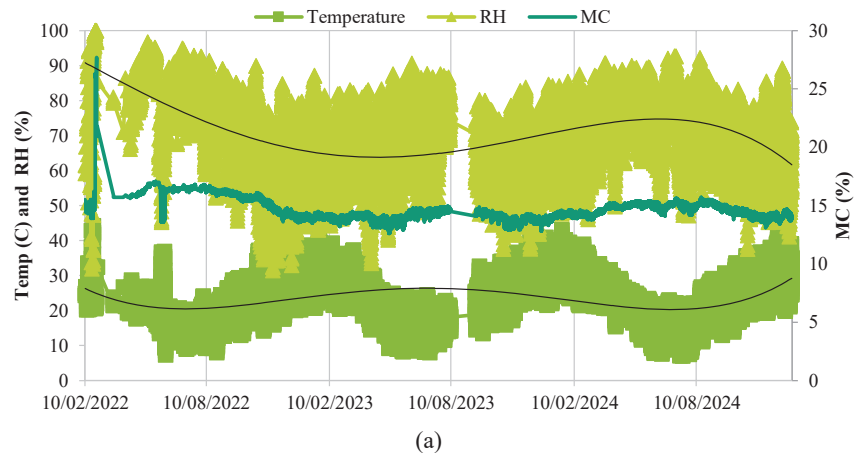
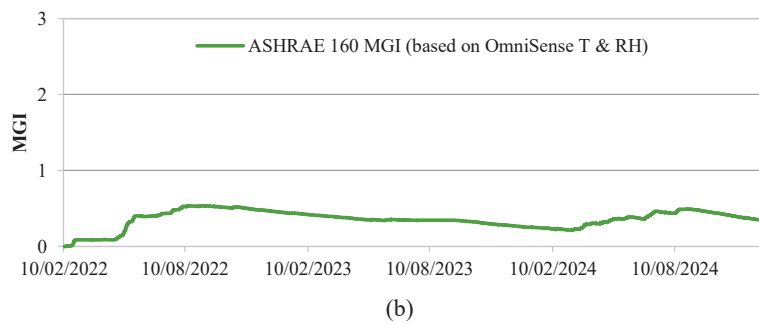
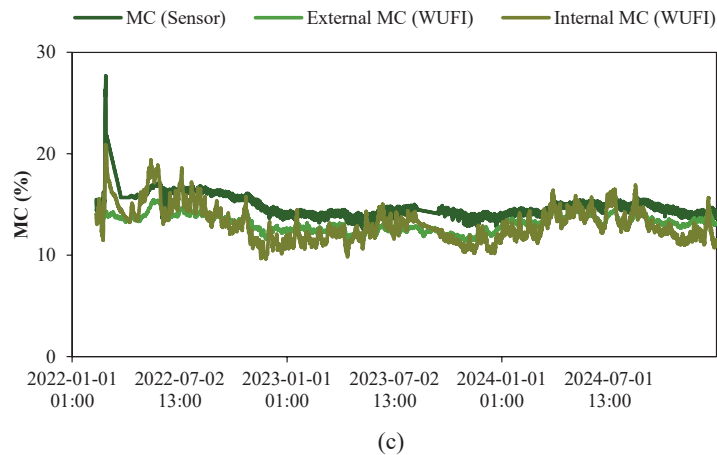
(c)
Figure 7: (a) Sensor recorded temperature, relative humidity and MC; (b) calculated MGI from the sensor data; and (c) comparison between measured and calculated MC values for the sensor located on the exposed floor panel and reading the external side of the panel at 20 mm depth

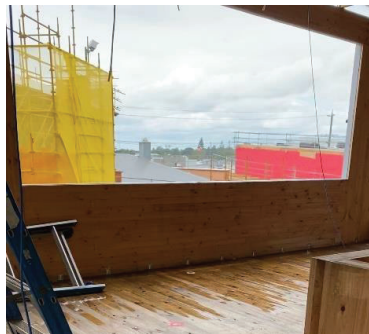
Figure 8 shows the wall and floor sections monitored for MC reading on level one of the buildings. Figure 9 and Figure 10 show the recorded values and calculated MGI for the wall panel with a large window opening, and the floor next to the wall respectively. As shown in Figure 9 (a) and Figure 10 (a), the recorded MC peaked during construction due to heavy rainfall entering the site through the large opening (Figure 8). However, as rain exposure stopped and building construction progressed,

Figure 8: Wall panel with large window opening.

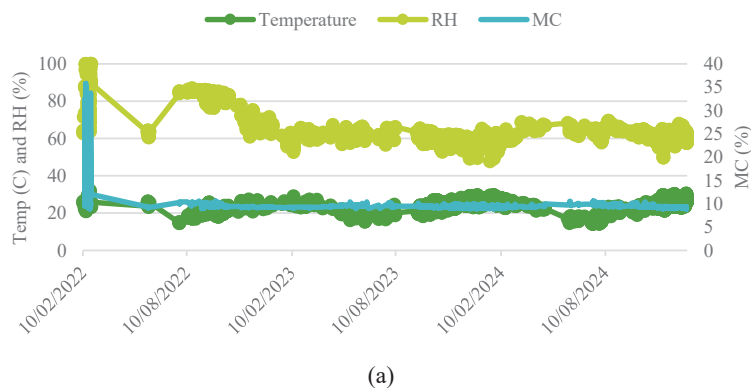
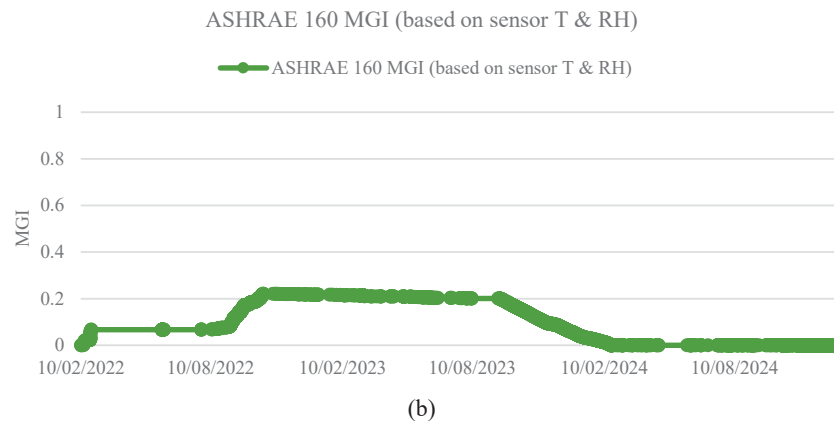
the MC remained at lower levels in both wall and floor panels. The MGI values, calculated using the sensor data, were very low, with only a small peak at the beginning of the recording period due to the moisture exposure. The small peak recorded in MGI calculations demonstrates the sensitivity of the predictive tool in determining areas at risk and also its effectiveness to highlight areas that might require further maintenance would the moisture exposure continued, or in case of construction delays where preventive measures are not applied in time

Figure 9: (a) Sensor recorded temperature, relative humidity and MC; and (b) calculated MGI from the sensor data for the sensor located on the wall panel with a large window opening and reading the external side of the panel at 20 mm depth.

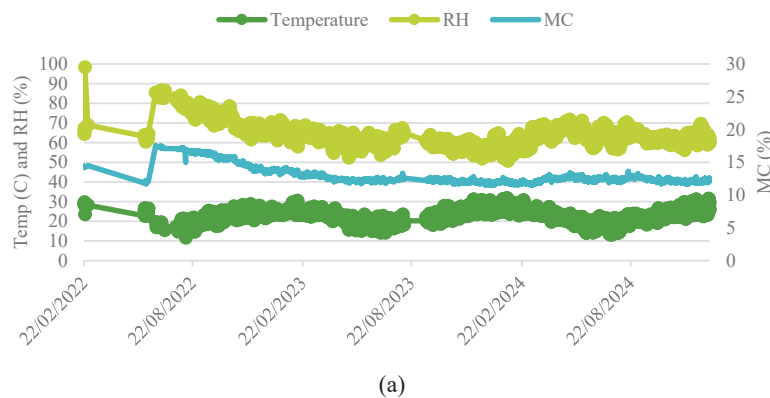
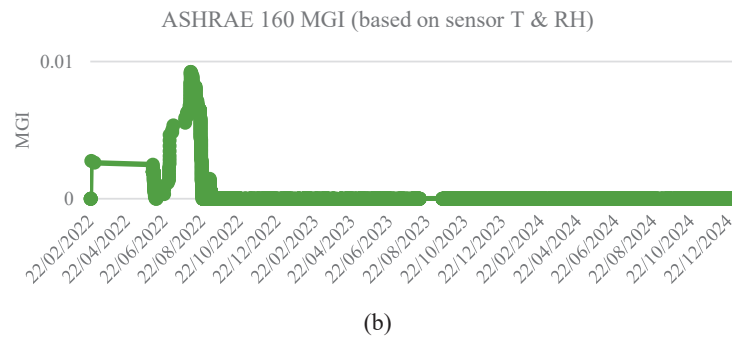
Figure 10: (a) Sensor recorded temperature, relative humidity and MC; and (b) calculated MGI from the sensor data for the sensor located on the floor panel next to the wall with a large window opening and reading the external side of the panel at 20 mm depth.
