Queensland Sedimentation and Evaporation Pond System (SEPS) Trial

Final Report
APL Project 2009/2248

June 2013

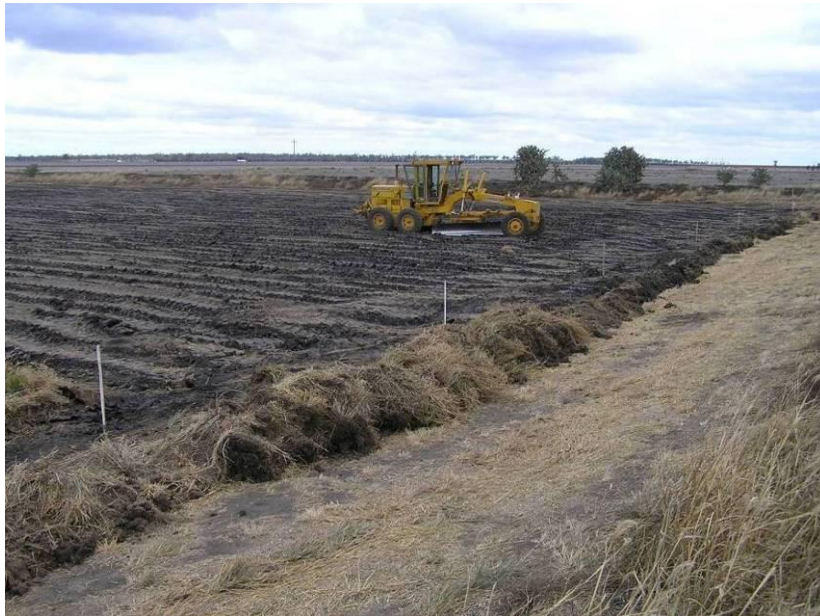
Figure 2: Stripping piggery solids from the base of the disused effluent evaporation pond in preparation for construction.

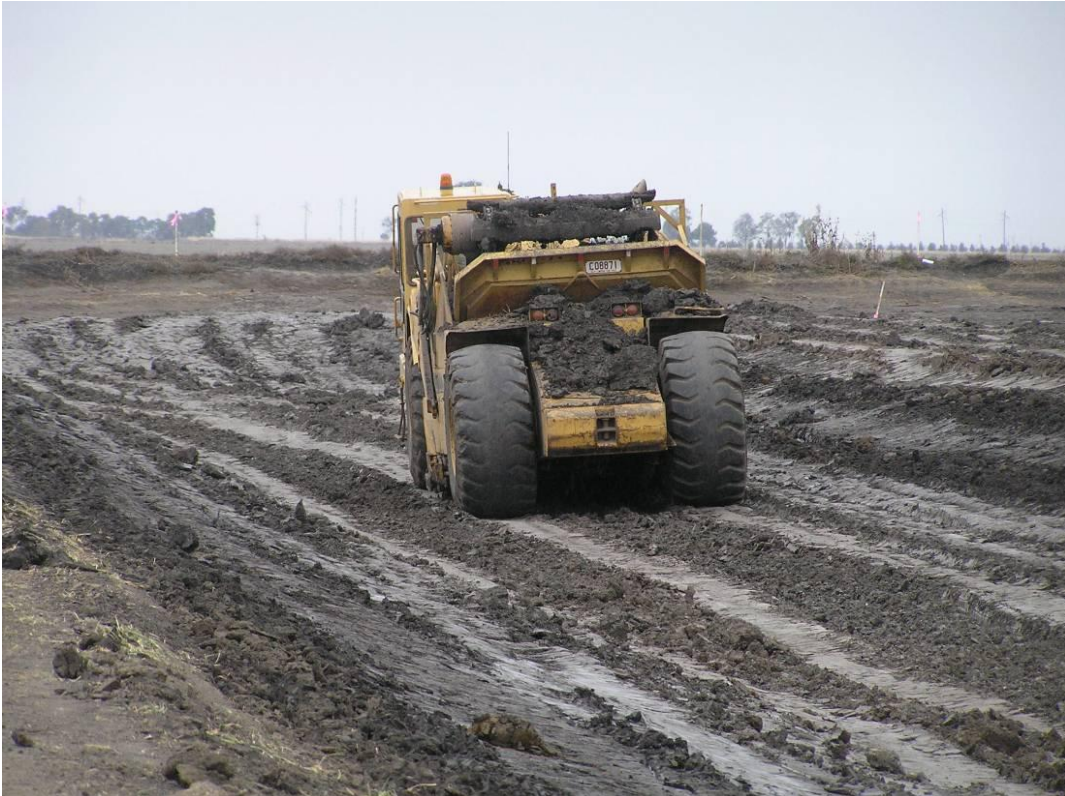
Figure 3: A scraper was used to remove material from the base of the SEPS channels for placement on the banks.

The earthworks for the SEPS were carried out over a 2 week period from 24 June to 6 July 2010. The machinery used in the earthworks construction included a scraper, dozer, grader, vibrating pad foot roller and water truck. As shown in Figure 1, the SEPS were constructed within a disused effluent evaporation pond. Figures 2 to 6 show various stages of the SEPS earthworks construction.

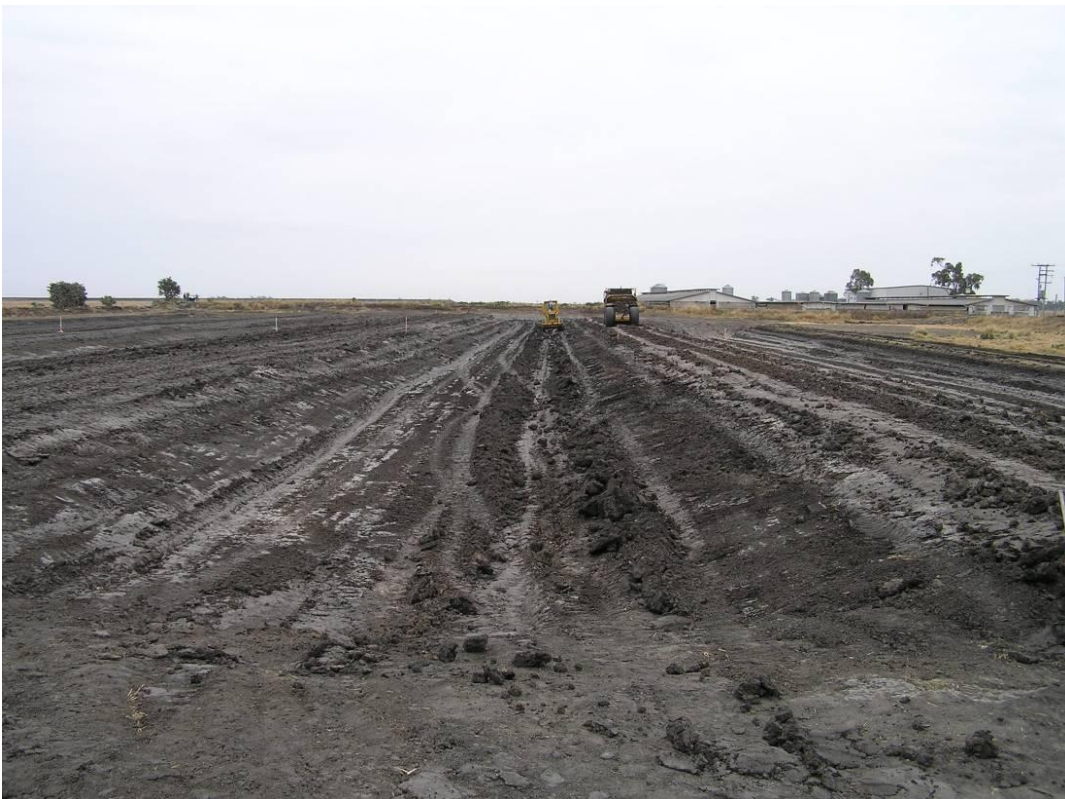
Figure 4: A grader was used to trim the earthworks following placement with the scraper and compaction using the vibrating pad-foot roller.

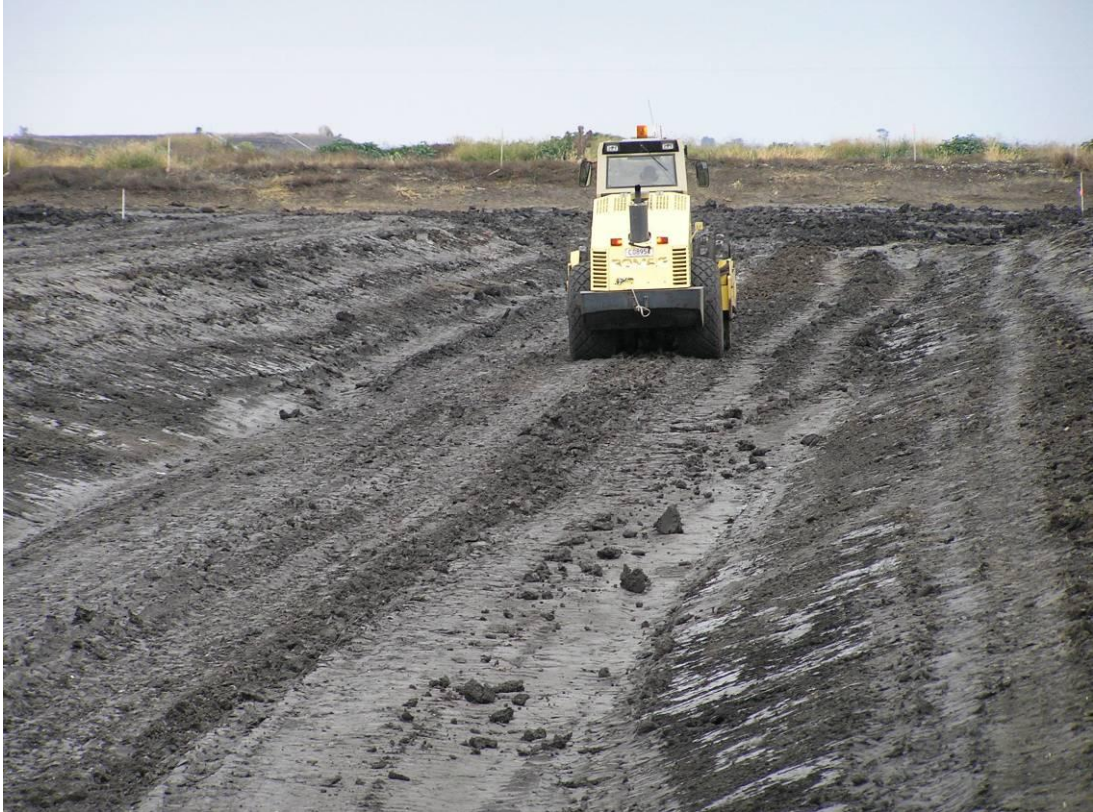
Figure 5: Vibrating pad foot roller compacting the base of one of the SEPS channels

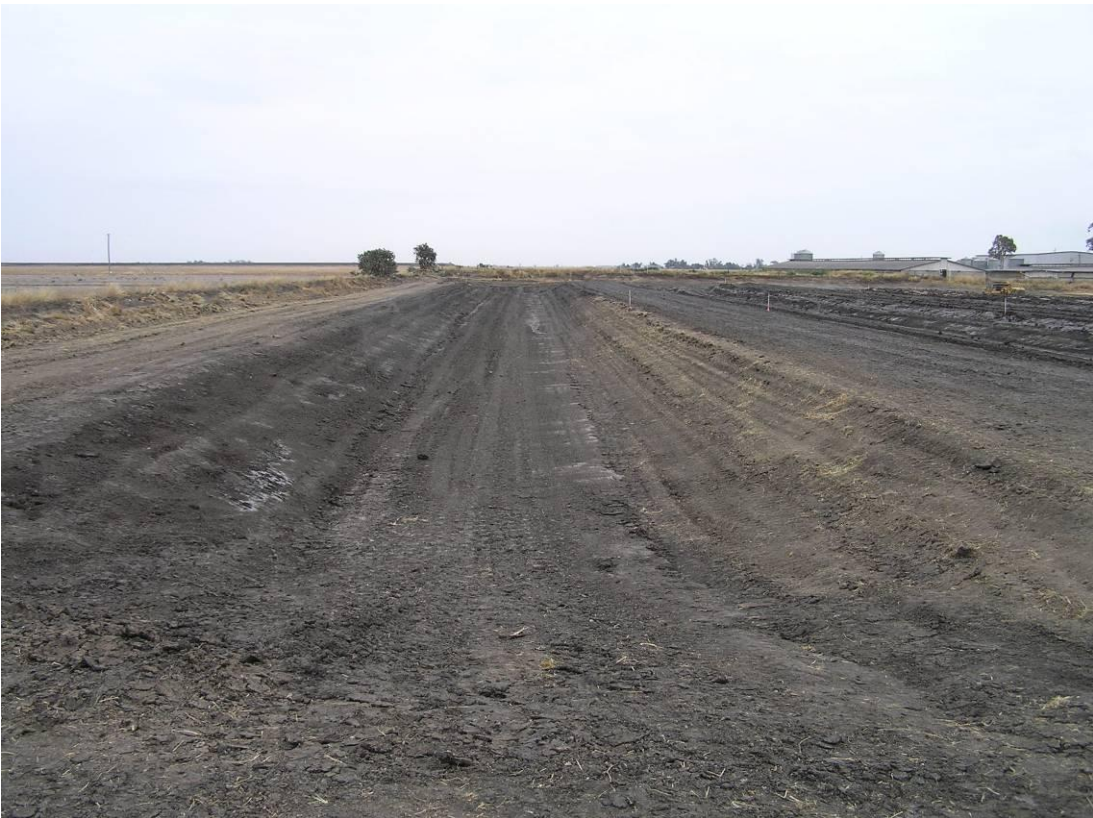
Figure 6: Completed SEPS channel.

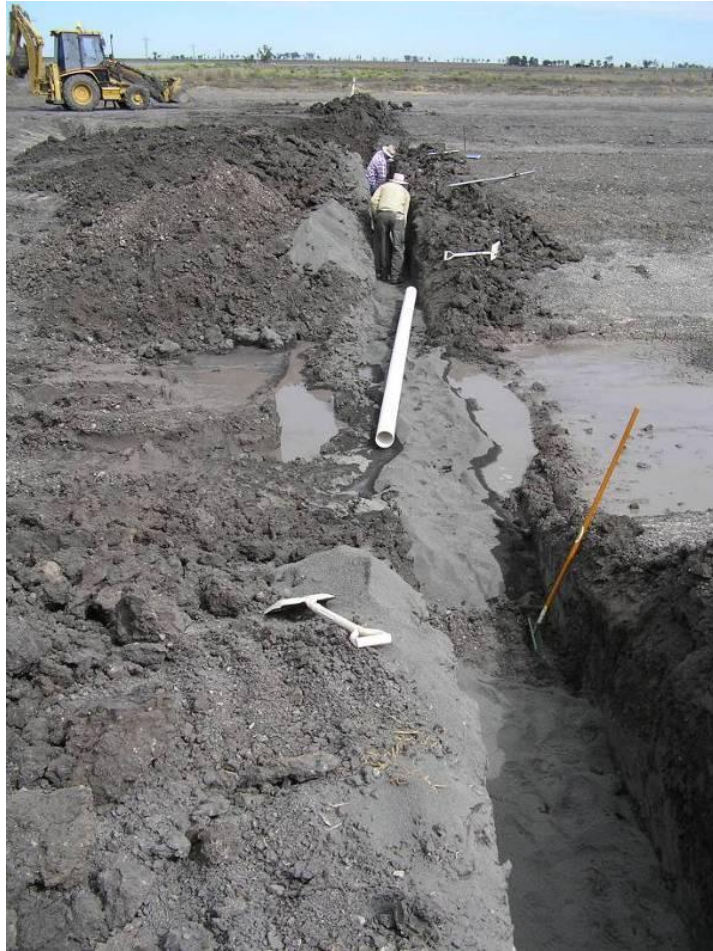
Figure 7: Laying individual 150 mm diameter PVC drainage pipelines from each of the SEPS channels to the return drain.

The SEPS drainage pipelines were installed on 5 August 2010. Separate 150 mm diameter PVC pipelines were installed from the lower (eastern) ends of each of the three SEPS channels, to the return drain. Each drainage pipeline was laid perpendicular to the SEPS channels, on a constant gradient of 0.5%, without any bends, to reduce the risk of blockages. A backhoe contractor was employed to assist with the pipe laying. A laser level was used to control the trench excavation and pipe laying process to ensure that a uniform pipeline gradient was achieved. Figures 7 and 8 show stages of the SEPS drainage pipeline installation.

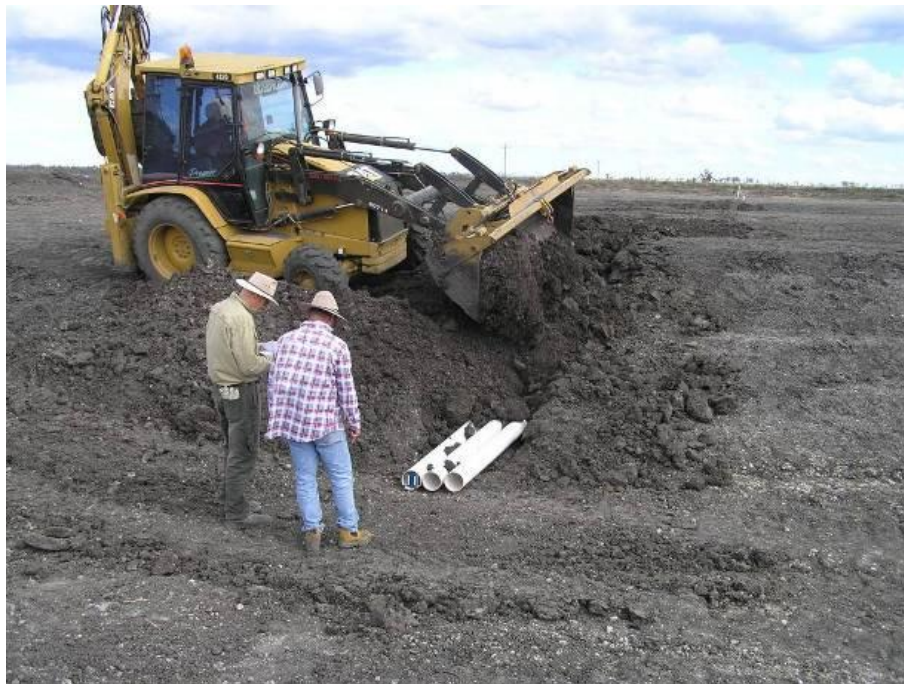
Figure 8: Backfilling the pipeline trench where the three SEPS drainage pipelines enter the return drain.

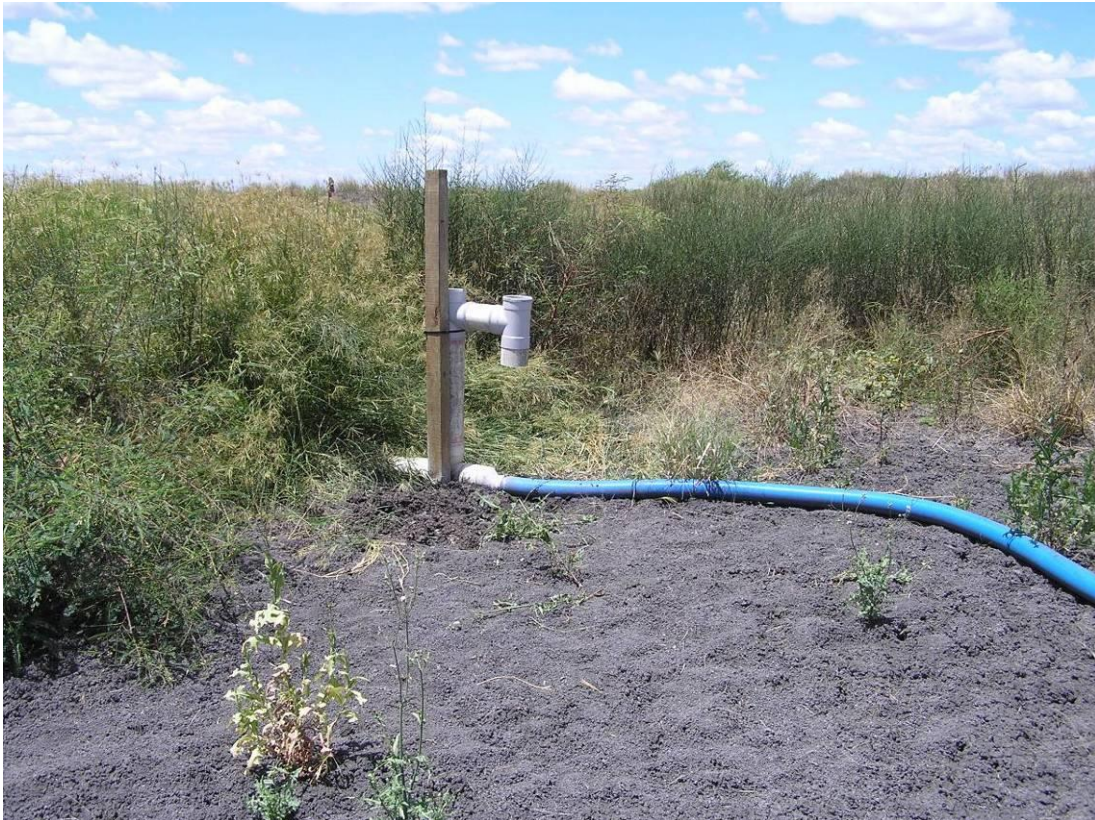
Figure 11: Revised overflow arrangement trialled in SEP 3 using 150 mm dia PVC riser and tee and 100 mm dia. flexible pump suction pipe.

Due to the flexibility of the 'Stormflex' pipe, it was found that the overflow arrangement described above did not operate successfully. Air locks in the 'Stormflex' pipe frequently impeded drainage of the SEPS. Replacement of the 'Stormflex' pipe with less flexible pump suction pipe improved the overflow operation. Prior to commencing pumping of effluent into SEP 3, the overflow arrangement shown in Figure 11 was installed. This arrangement used a fixed 150 mm diameter PVC riser and tee to prevent floating crust material from entering the drainage pipe. This system was found to work relatively successfully.

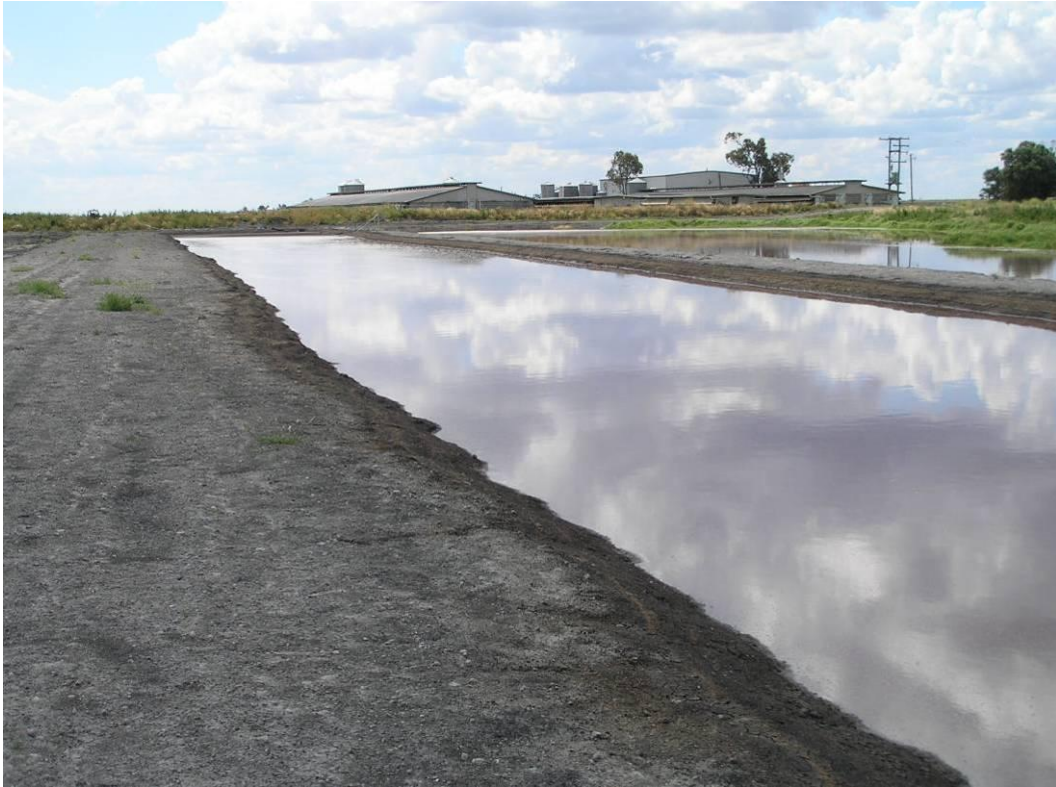
Figure 12: Photograph of the first SEPS channel and return drain on 5 November 2009, after approximately one month of active operation.

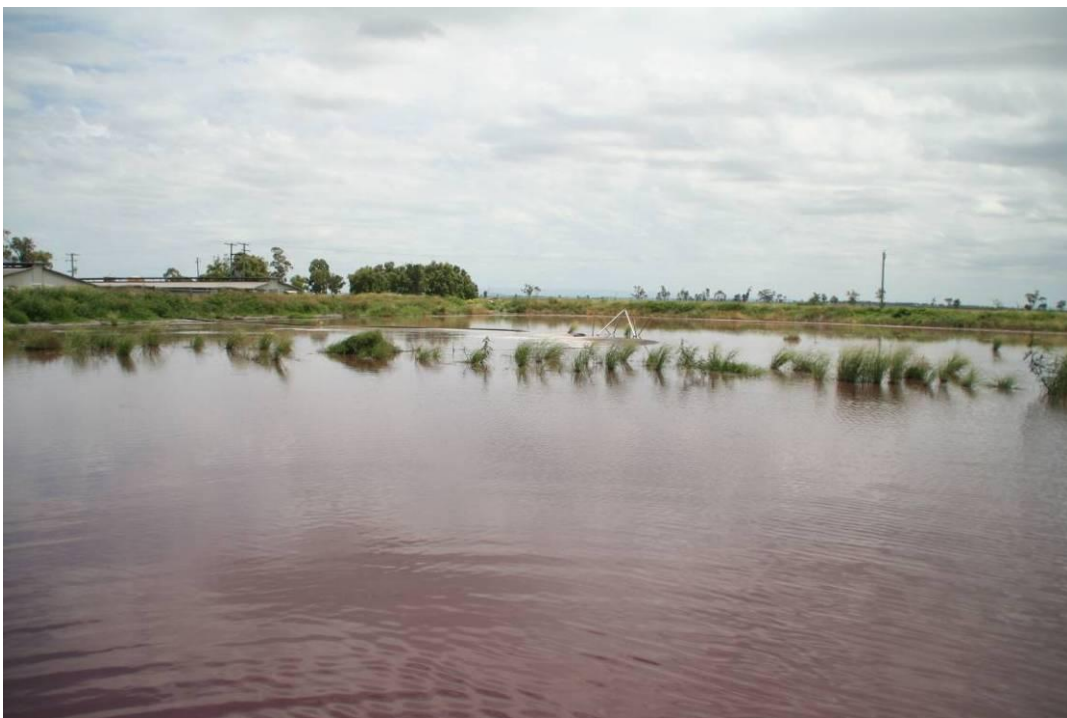
Figure 13: Photograph of the SEPS on 17 January 2011. All three SEP channels and the return drain were filled with effluent following the extreme wet conditions experienced over the summer of 2010-11.

Southern Qld experienced an extremely wet summer 2010-2011, which resulted in severe flooding of many areas. The December 2010 rainfall at Bowenville (Bureau of Meteorology Station No 41008) was 305 mm, the second highest December rainfall recorded since records commenced in 1889. The January 2011 rainfall was 217 mm, which exceeded the 97th percentile monthly rainfall for January. Under the extreme wet conditions, the piggery manager was forced to pump effluent into each of the three SEPS channels and the return drain, as all wet weather storage capacity available on the farm was full. Figure 13 shows the inundated SEPS on 17 January 2011.

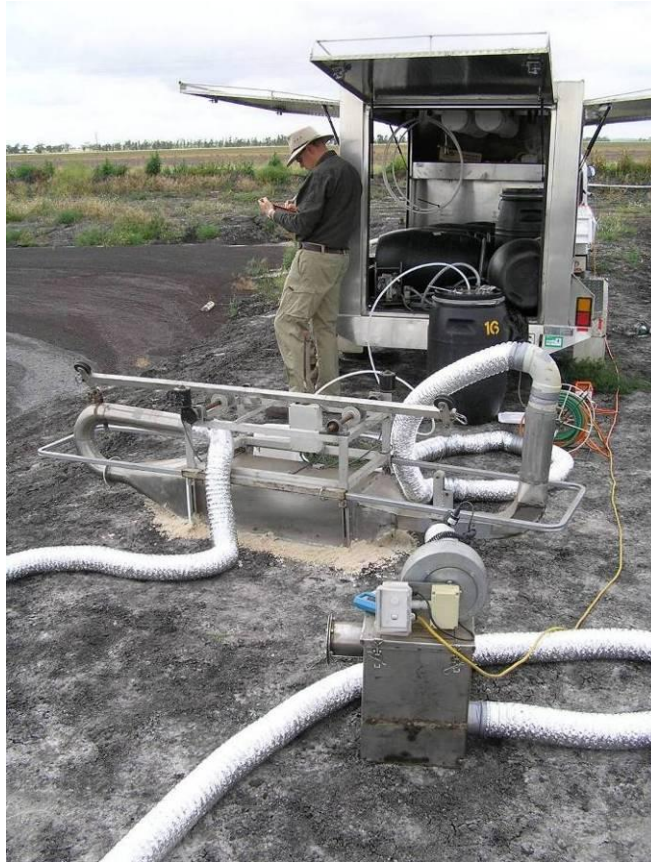
Figure 14: Collecting a blank odour sample using the Agri-Science wind tunnel positioned on a stainless steel sheet adjacent to the SEP channel (November 2011).

At the start of each sampling day, blank samples were collected by placing the wind tunnel on a stainless steel sheet that had been cleaned using acetone. Blank samples are required to demonstrate that the equipment does not contain any odour contaminants and to establish a baseline for comparison with the actual samples. Clean, slightly damp sand was placed around the perimeter of the wind tunnel base to minimise leakage.

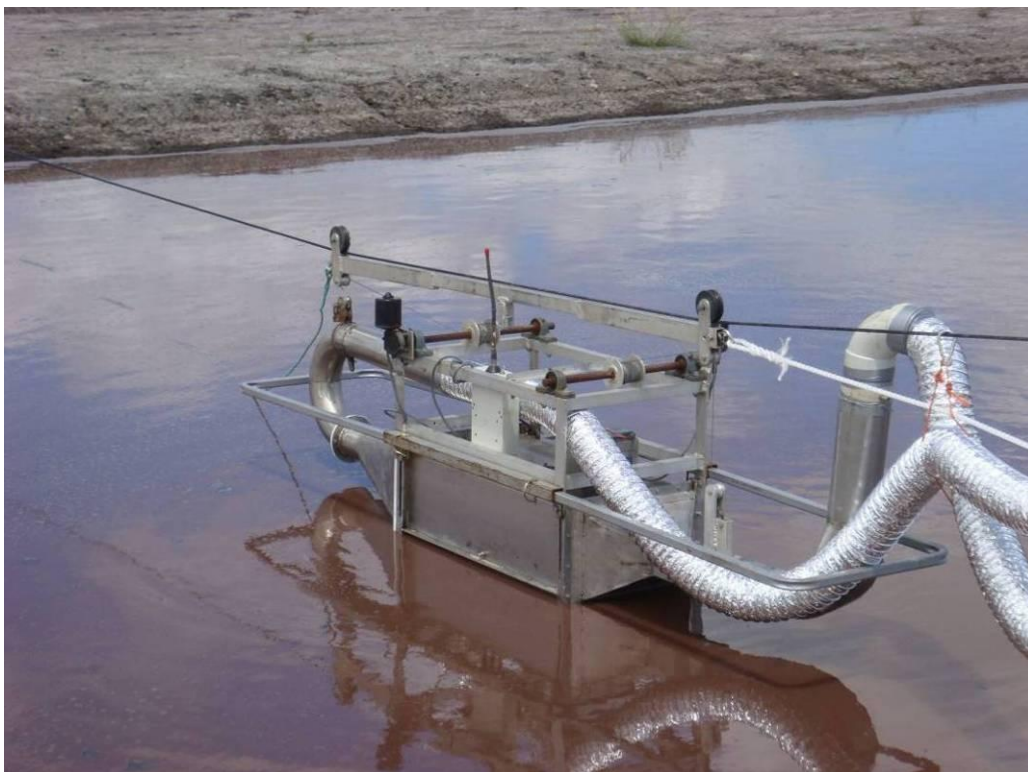
Figure 15: Wind tunnel collecting odour sample from near the eastern end of the SEPS channel (25 November 2010).

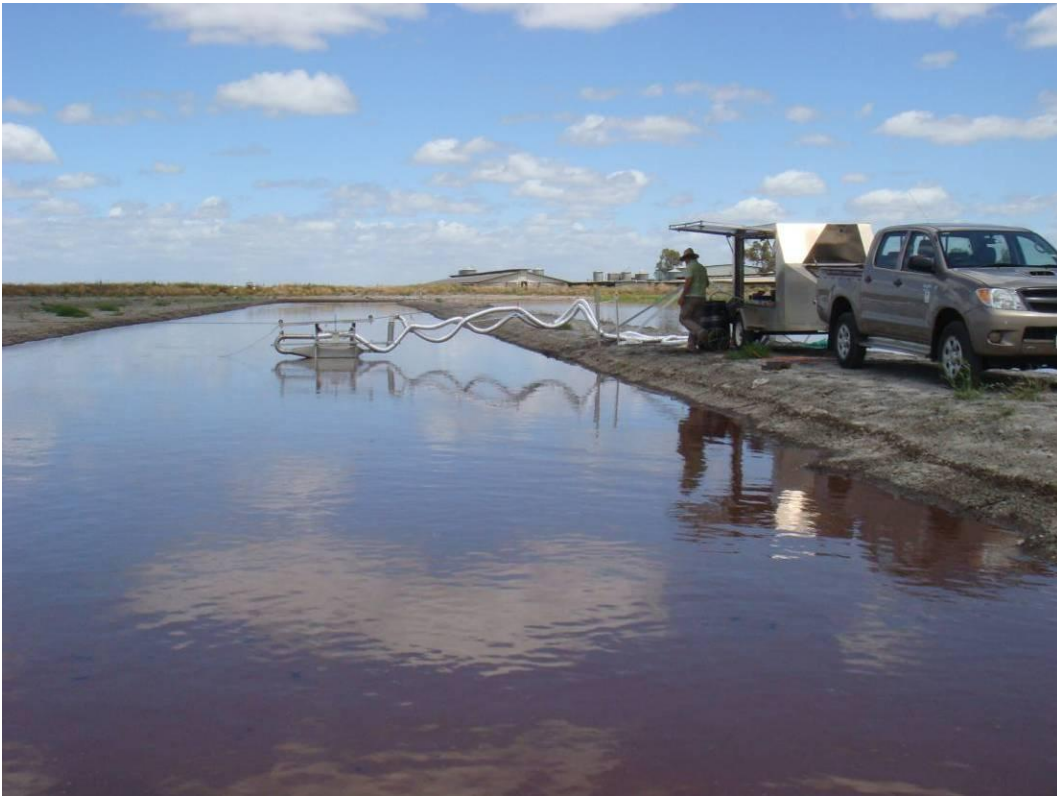
Figure 16: Odour sampling near eastern end of SEPS channel (25 November 2010).

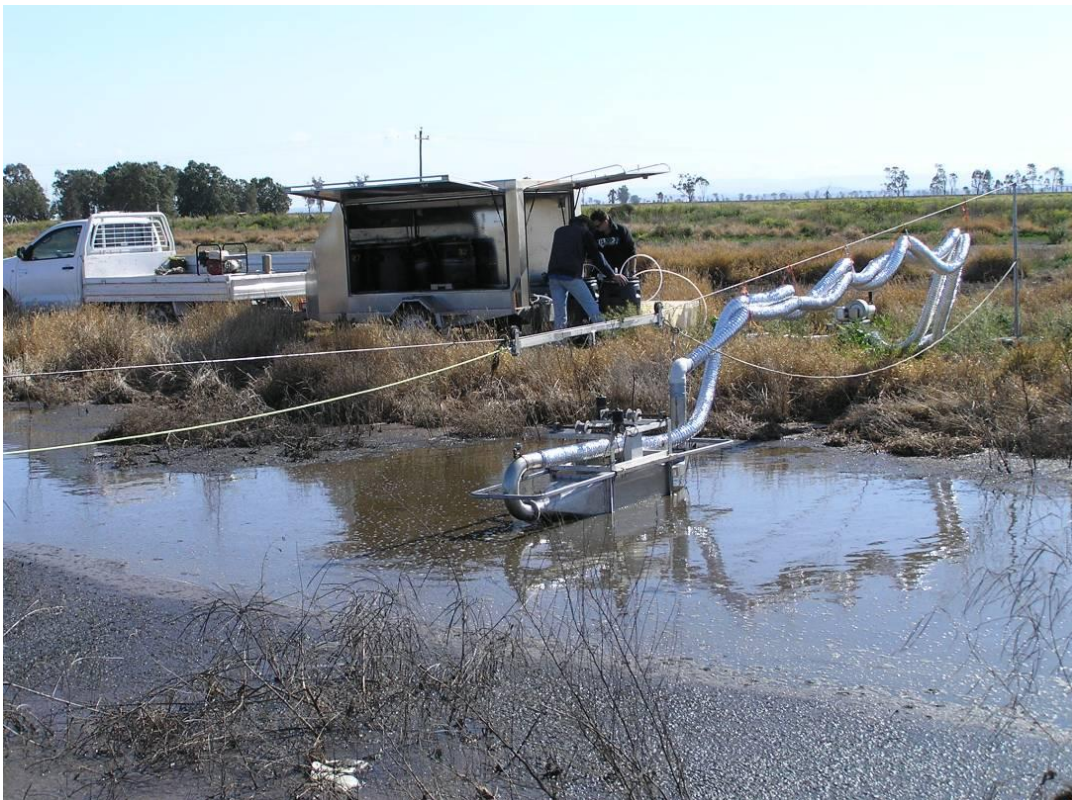
Figure 17: Wind tunnel collecting odour sample from near the western end of the SEPS channel, close to the location where the shed effluent enters the SEPS (28 August 2012).

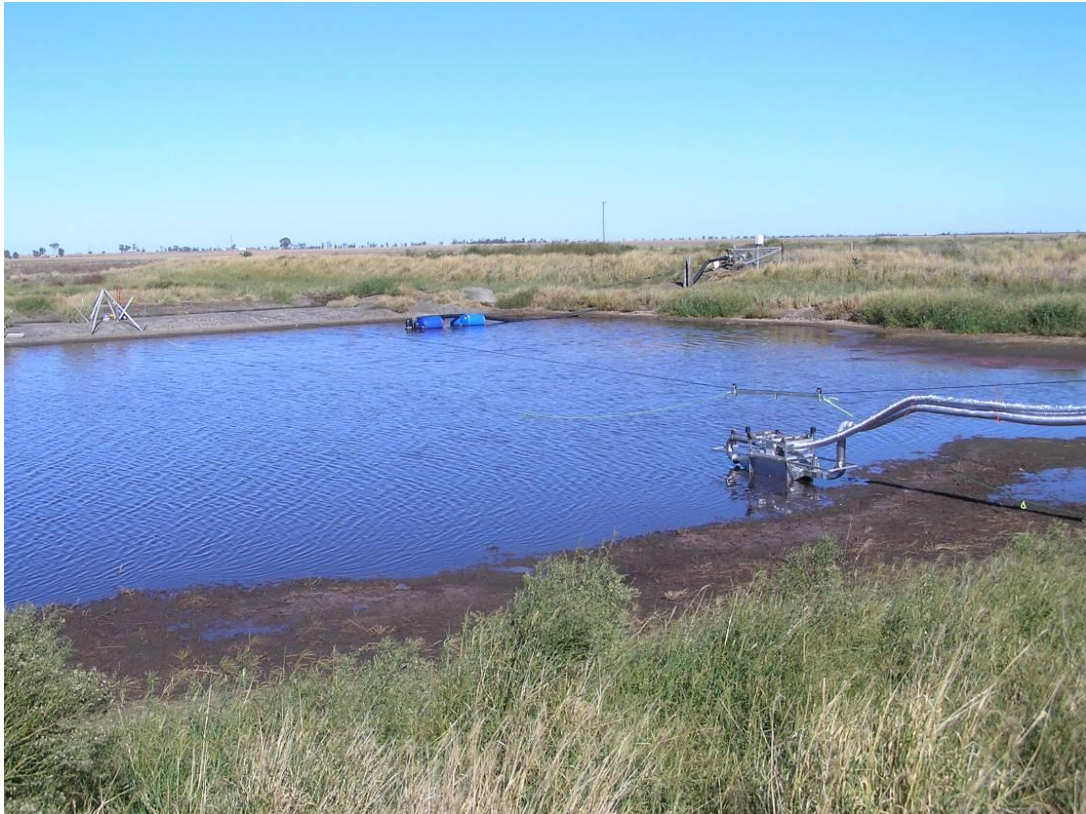
Figure 18: Wind tunnel sampling near the western end of the return drain (12 April 2012).

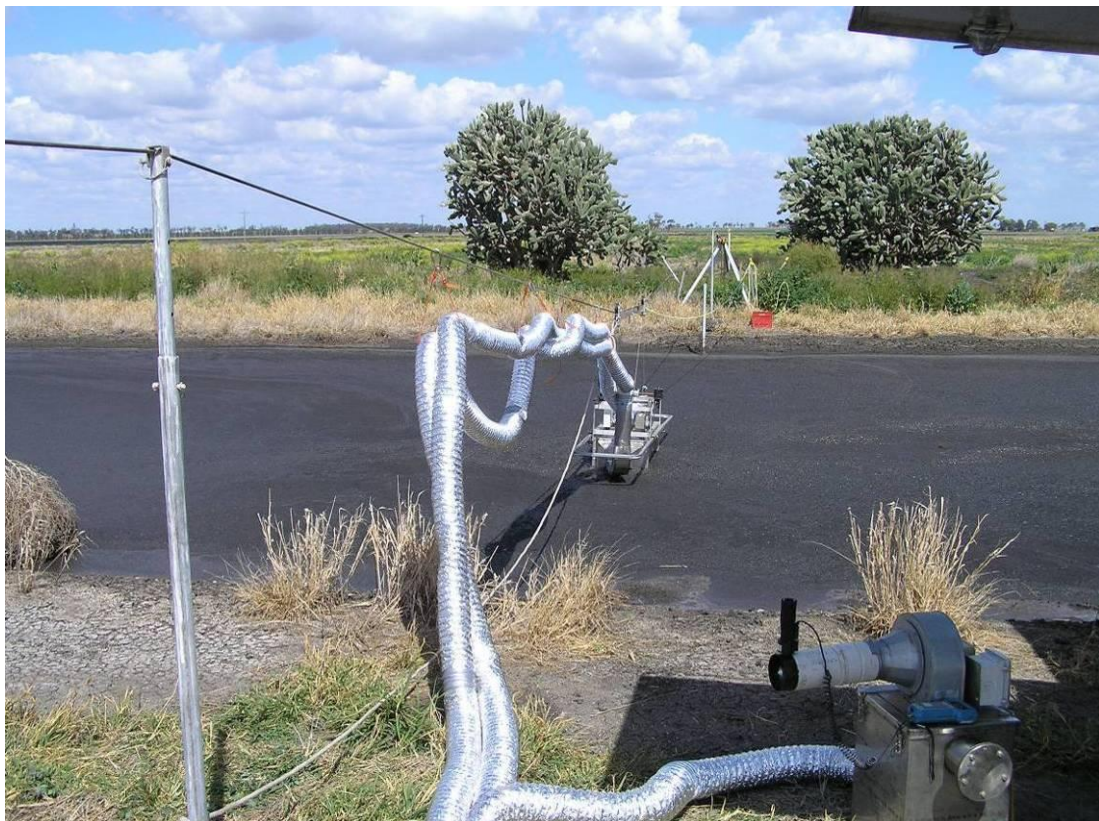
Figure 19: Odour sampling from the upstream end of SEP 3 (active SEP) on 28 August 2012 using the wind tunnel.

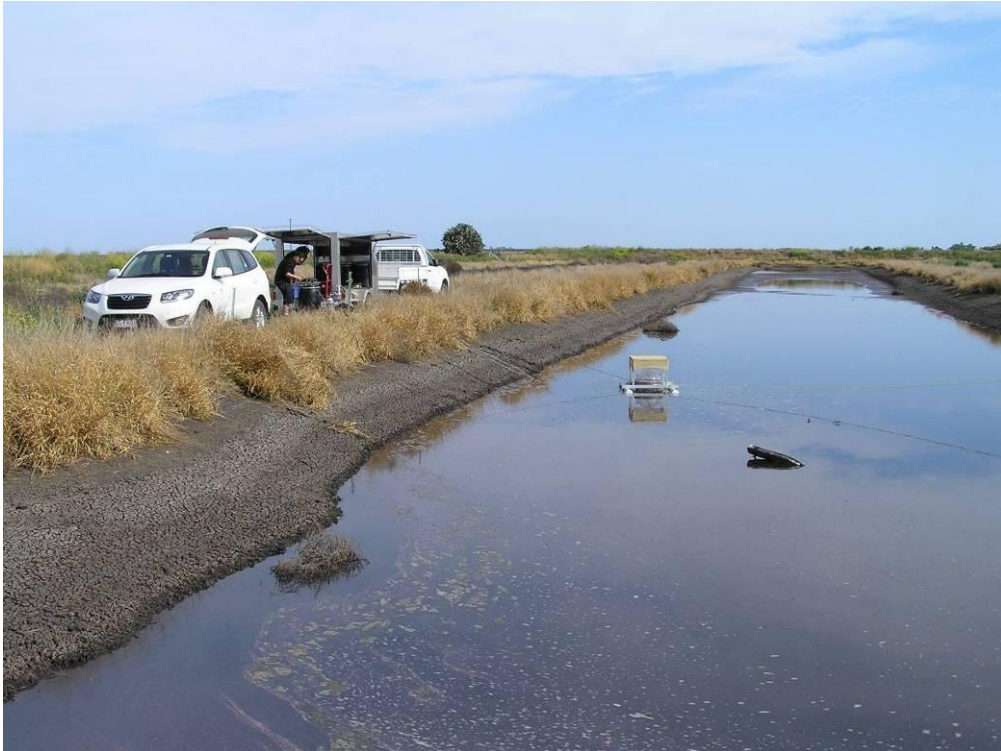
Figure 20: Odour sampling from the downstream end of SEP 2 (drying SEP) on 29 August 2012 using the flux chamber.

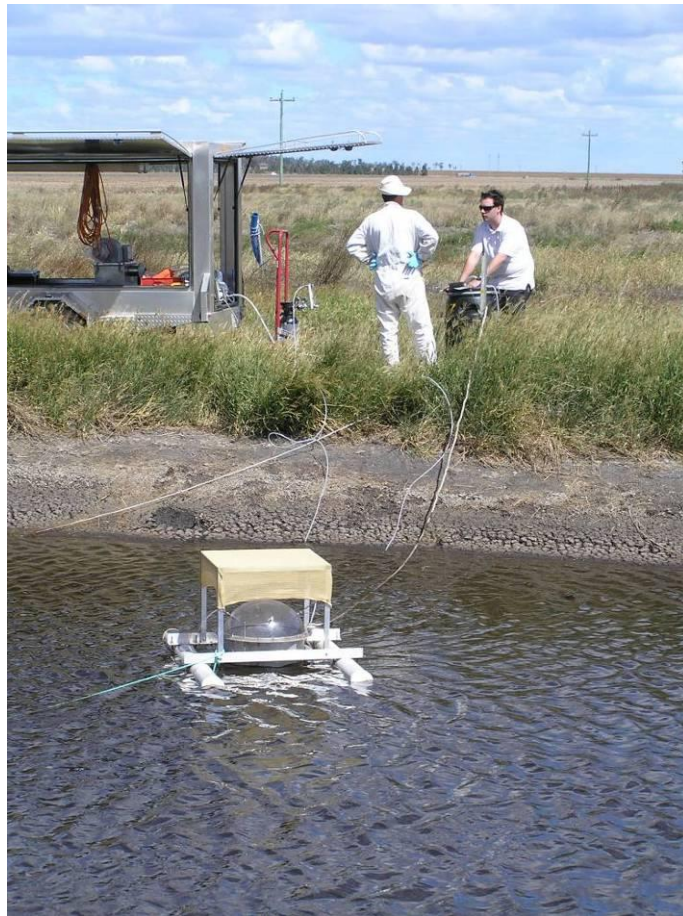
Figure 21: Odour sampling from the return drain using the flux chamber (12 April 2012)

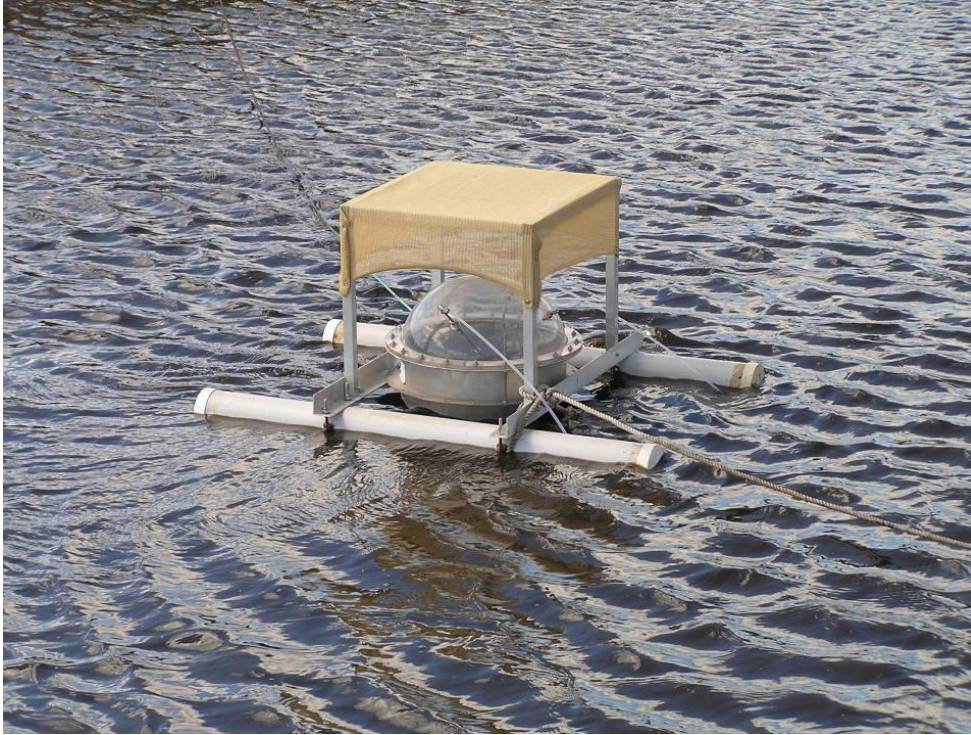
Figure 22: Close-up view of the flux chamber collecting odour sample from the return drain (12 April 2012).

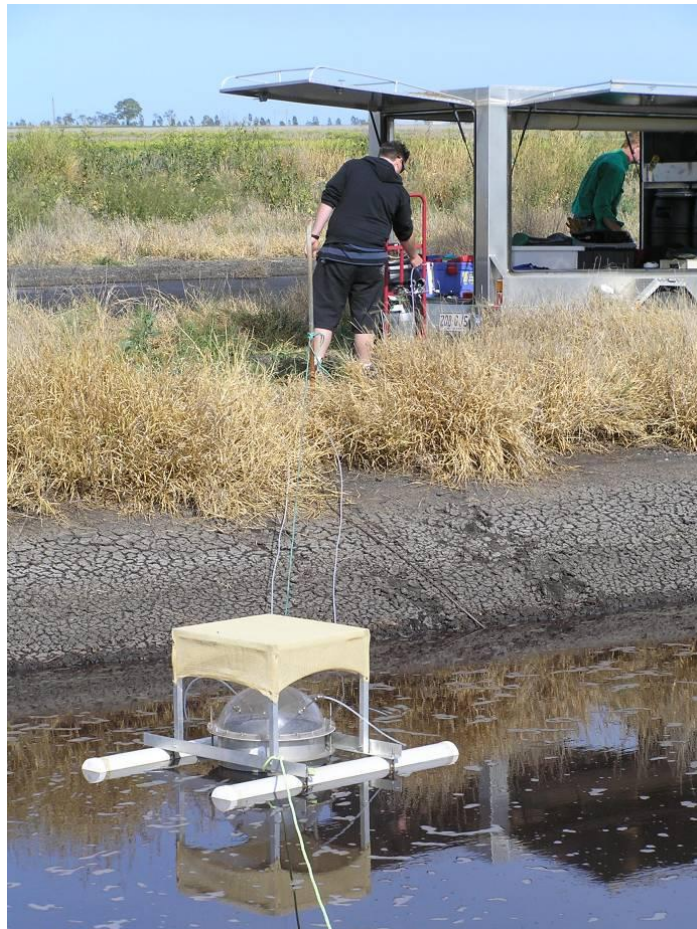
Figure 23: Flux chamber sampling from the drying SEP 2 on 29 August 2012.

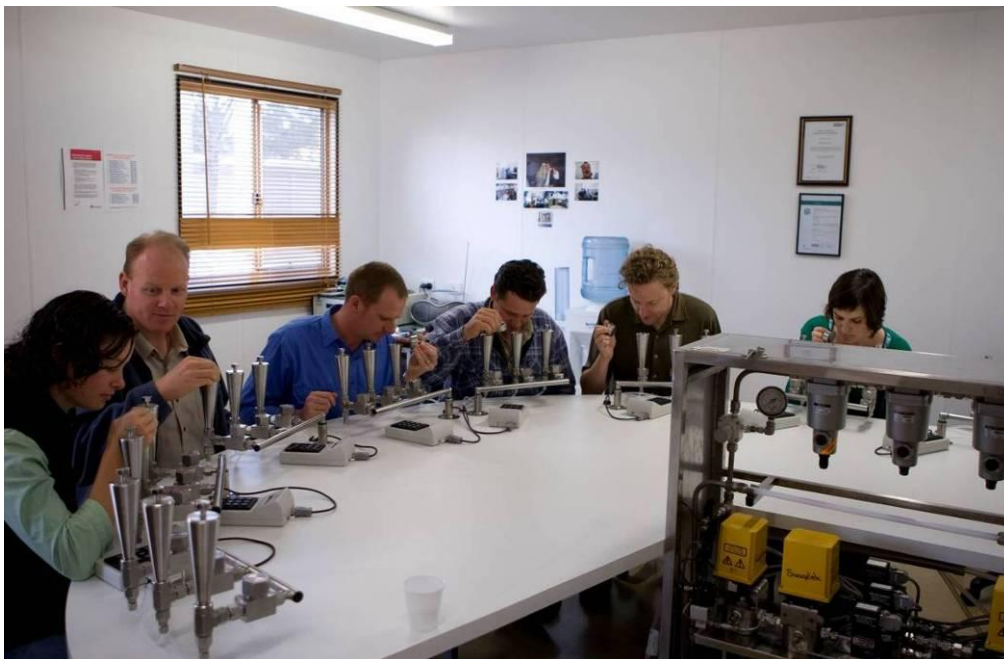
Figure 24: The Agri-Science Queensland olfactometer in operation showing panellists sniffing at ports.

Following delivery of the sampling drums from the SEPS site, odour concentrations were determined using an eight panellist, triangular, forced-choice dynamic olfactometer developed by Agri-Science Queensland (formerly Department of Primary Industries and Fisheries (DPI&F)), as shown in Figure 24. This olfactometer was constructed to meet the requirements of the Australian/New Zealand Standard for Dynamic Olfactometry (AS4323.3). The development of the olfactometer has been described previously.

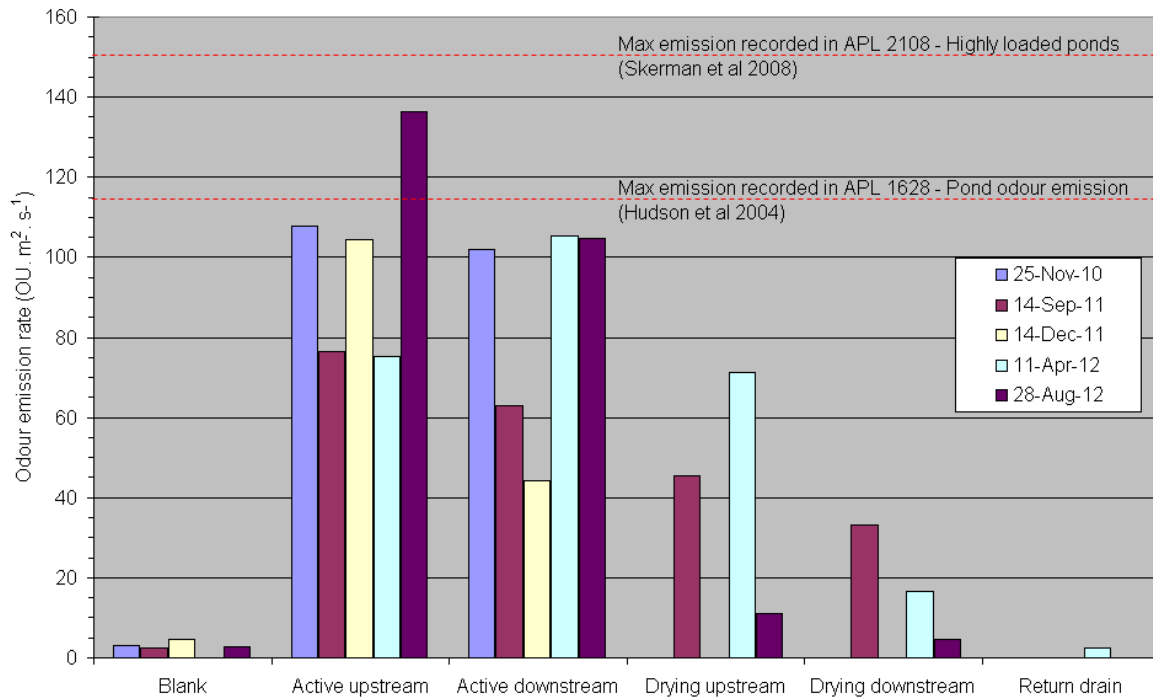
Figure 26: Odour emission rates for samples collected using the wind tunnel, arranged by various areas of the SEPS.

The data, summarised in Table 4 and in Figure 26 and Figure 27, suggests that odour emission rates were generally highest near the inlet (upstream) end of the active SEPS. Based on the wind tunnel data, the average emission rate near the inlet end of the SEPS ($100 \text{ ou.m}^3.\text{m}^{-2}.\text{s}^{-1}$) was approximately 20% higher than near the outlet end ($84 \text{ ou.m}^3.\text{m}^{-2}.\text{s}^{-1}$). The odour emission rates from the drying SEPS were generally lower than for the active SEPS, while the odour emission rates from the return drain were barely detectable using olfactometry.

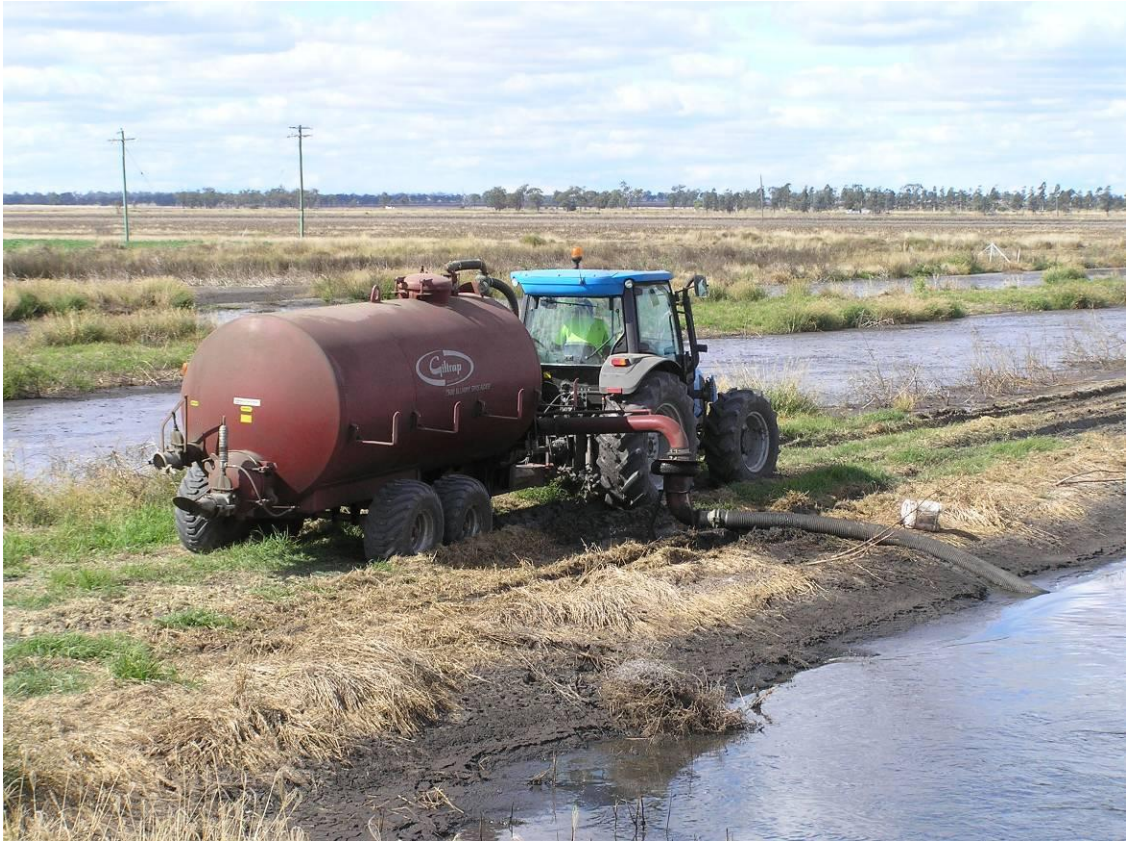
Figure 29: Giltrap slurry spreader lifting agitated slurry from SEP 3.

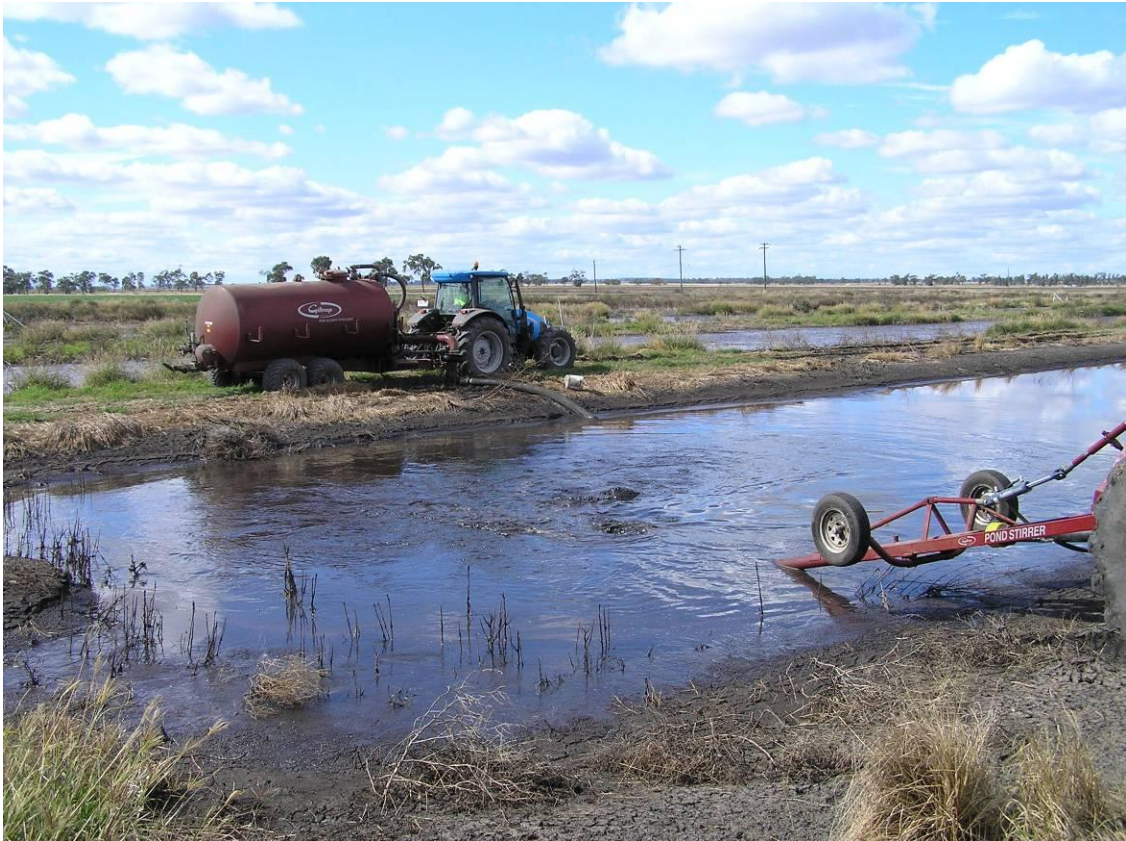
Figure 30: Giltrap slurry spreader and pond stirrer operating on SEP 3.

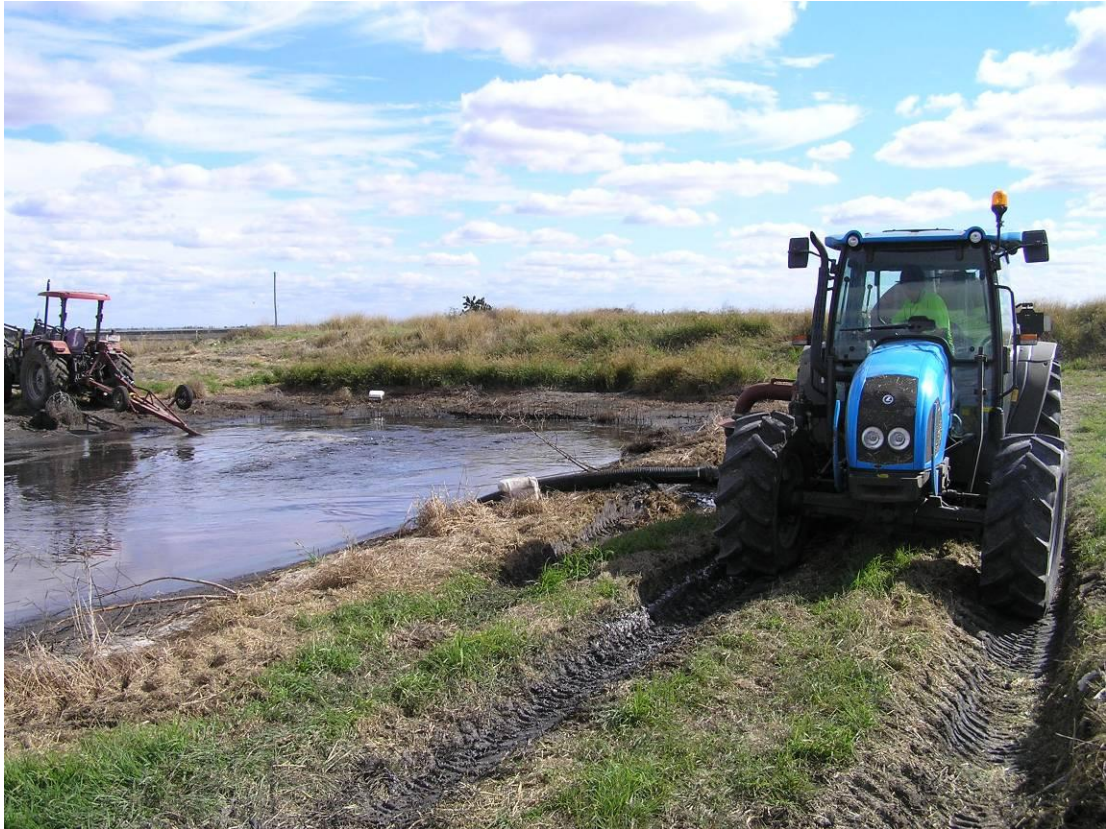
Figure 31: Giltrap slurry spreader and pond stirrer operating near the upstream end of SEP 3.

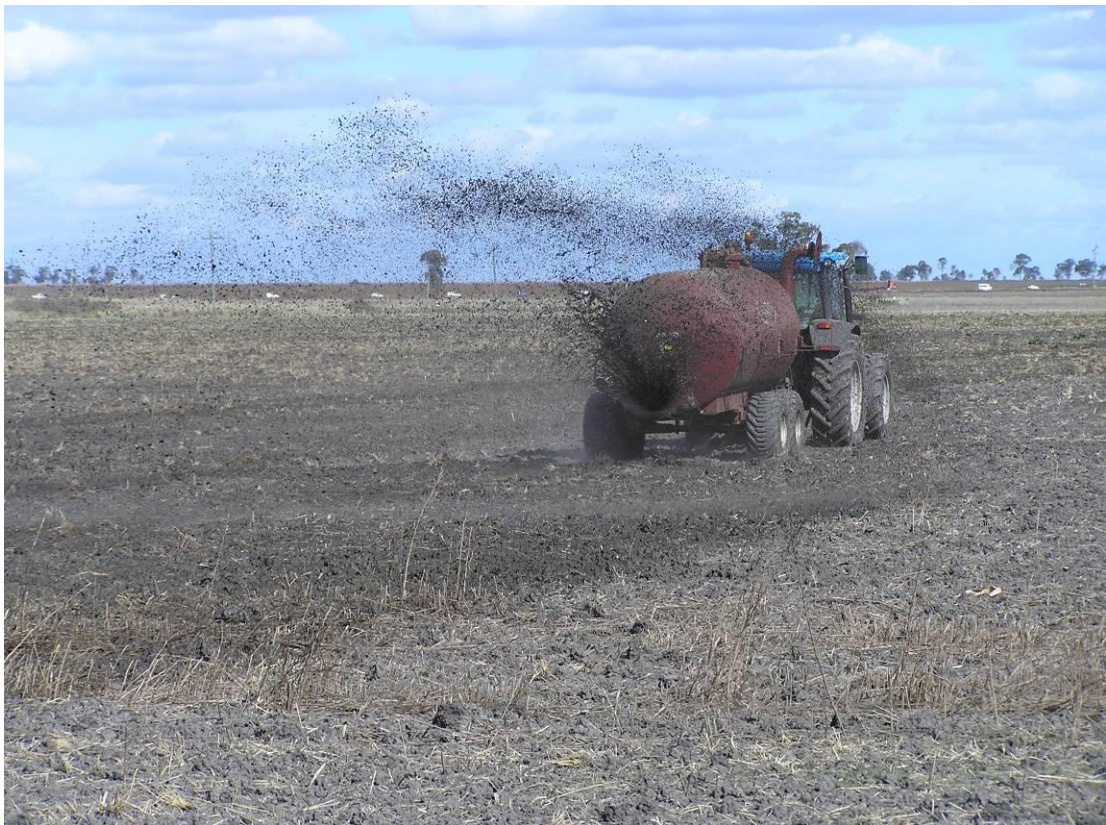
Figure 32: Giltrap slurry spreader applying slurry to nearby cultivation paddock.

The vacuum tanker spread the slurry onto a cultivated paddock located directly south from the SEPS. It is anticipated that a wheat crop for hay production will be planted in this paddock in the near future. Very little odour was observed throughout the solids removal and application process. It is understood that most of the accumulated solids were successfully removed from SEP 3 and approximately half the solids were removed from SEP 1 over a period of approximately 4 days. The contractor had not advised the number of tanker loads applied to the cultivation at the time that this report was completed. The piggery manager is expecting to receive this report from the contractor in the near future.
