Proceedings of the Australian Association of Animal Sciences

34th Biennial Conference

Remediation of dam by-wash with rock chute in central Queensland

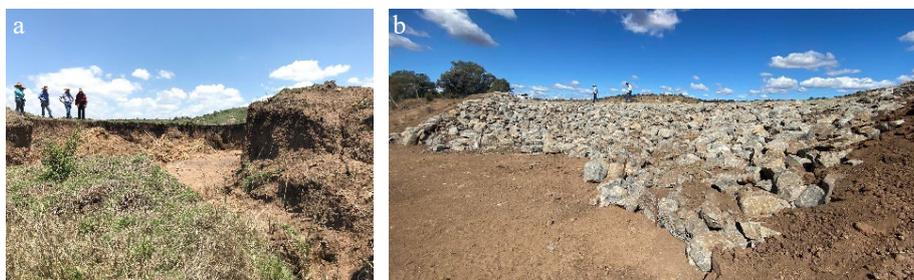
The rock chute was completed on 21 July 2021 and 402 mm of rainfall was received at the site from completion to 28 February 2022. Visual site assessments indicated very limited sediment movement at the apron of the rock chute (Fig. 1b).

Fig. 1. Erosion at the dam by-wash prior to rock chute construction (a) and the completed rock chute (b).

The rock chute design specifications included a 35 m chute crest around the top of the gully, a batter of 3:1 through the gully head, a 6-m chute batter and an apron length of 2 m and depth of 0.3 m to dissipate the water turbulence. Earth moving at the site began with shaping the level crest and batter, then excavation of 0.6 m deep cut off trenches around the chute crest and at the end of the apron. Excess soil from the shaping and battering of the chute was used to construct a diversion wing bank to direct water over the rock chute. Geofabric was laid across the top cut off trench and the top of chute batter. The geofabric was keyed in underneath a layer of compacted gravel and 600 mm quarry rock. A wire netting fence was erected at the bottom of the rock chute to hold rock in place and catch debris to further stabilise the site.
