# OBSERVATIONS ON THE "BARE SOIL" METHOD OF GRASSED WATERWAY ESTABLISHMENT

By J. ROSSER, Q.D.A., B.Agr.Sc.\*

## SUMMARY

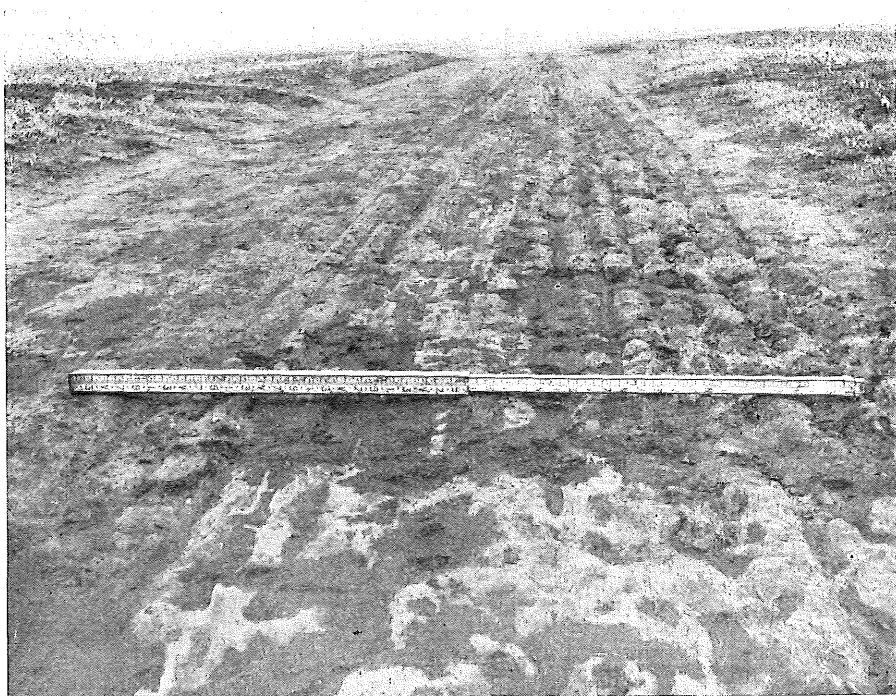
Fig. 2.—Same waterway as Fig. 1 on 16.i.1956 after four flows.

*Rates of Colonization.*—Figures 1-4 show four stages in the grassing of this waterway. The most recent, taken in May 1959, shows the grasses meeting in places—and a bare patch 5 ft wide still to be covered in others. Had common African star grass been used from the outset, colonization would probably have been quicker. In any case, it is clear that nearly four years after establishment the waterway is still quite stable and well on the way to complete colonization by the grasses.

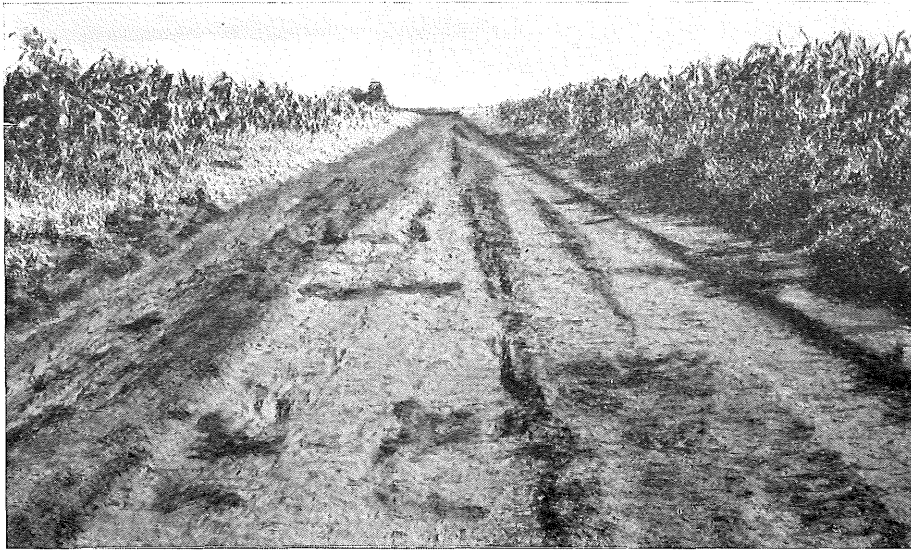
Fig. 3.—Same waterway as Fig. 1 on 17.ii.1956 after a fifth flow in which the waterway flowed at full capacity at a calculated average velocity of 11 ft./sec. The waterway floor is quite bare and perennial grasses planted on the banks have made little growth.

On February 3, 1956, the waterway flowed 1.5 ft deep. From measurement of cross-sectional area and hydraulic radius of flow it is calculated that approximately 300 cu. ft. of water flowed down the waterway per second at an average velocity of 11 ft/sec. At this stage the waterway was still quite bare.

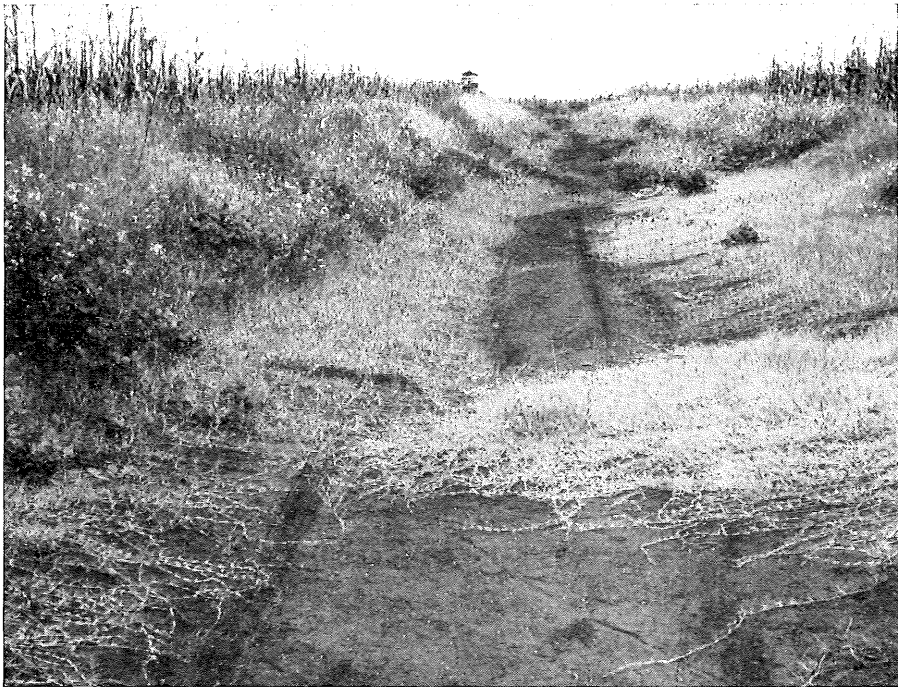
Fig. 4.—Same waterway as Fig. 1 on 30.v.1959. Waterway is still in good order and colonization has proceeded to the stage where grass will shortly meet in the centre.

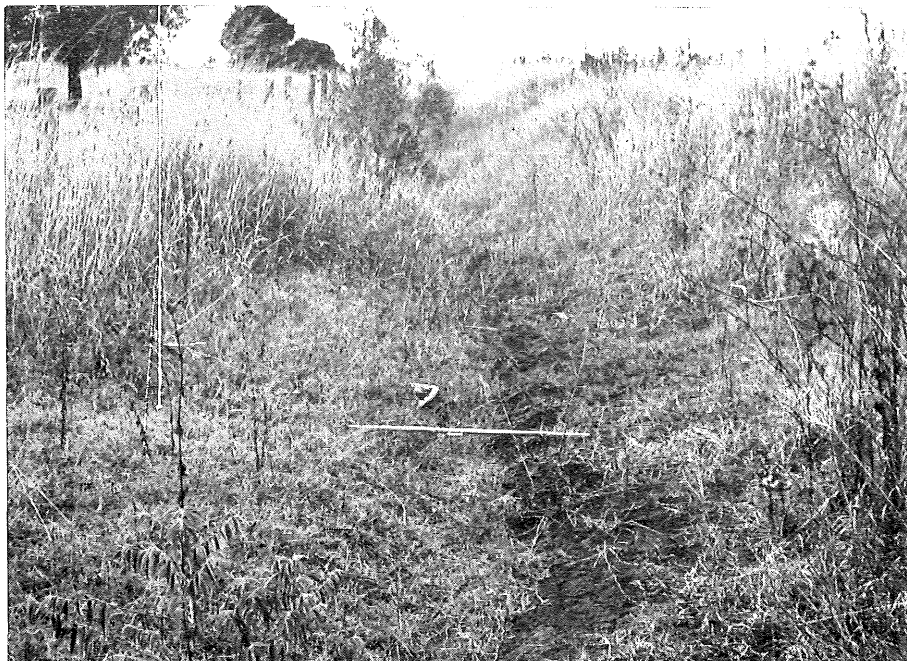
Fig. 7.—Scrub soil waterway stabilized by couch and Rhodes grasses. Centre rill 0.5–1.5 ft deep has common couch grass growing in the bottom. Photographed 2½ years after construction. Waterway 3 in Table 2.

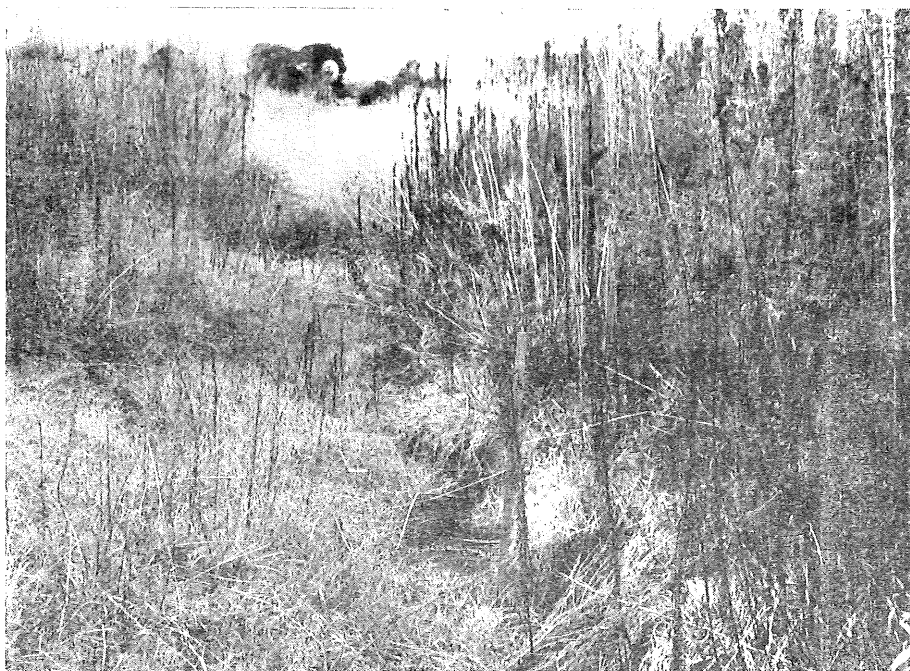
Fig. 8.—This scrub soil waterway has a centre gully 0.5–3.0 ft deep. Common couch grass is stabilizing the gully, which is now partly filled with silt. Waterway 6 in Table 2.

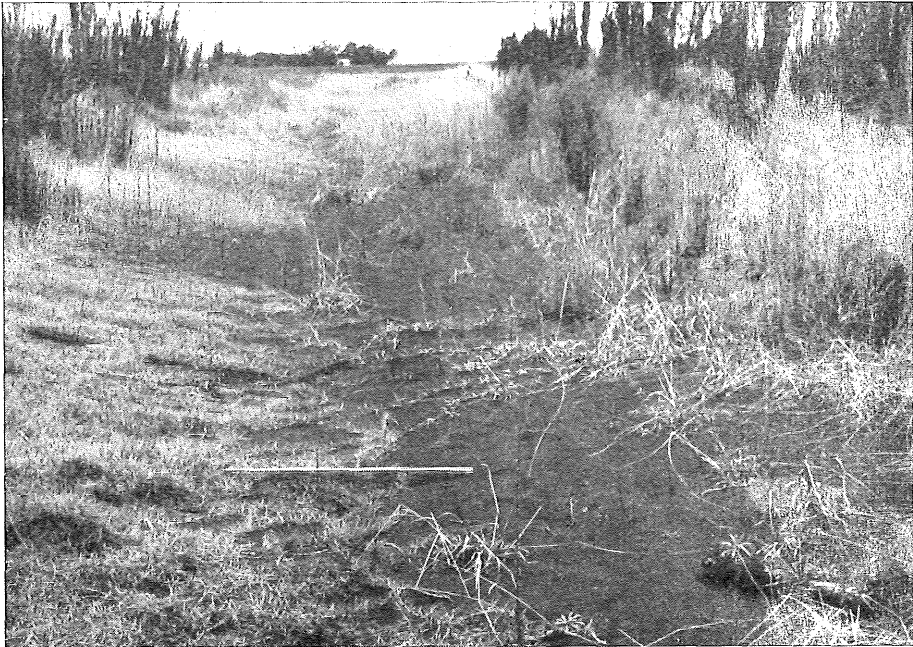
Fig. 9.—Grass was not planted in this scrub soil waterway. Some kikuyu grass plants were accidentally established on the left bank during construction and have now spread to the centre. Waterway 7 in Table 2.

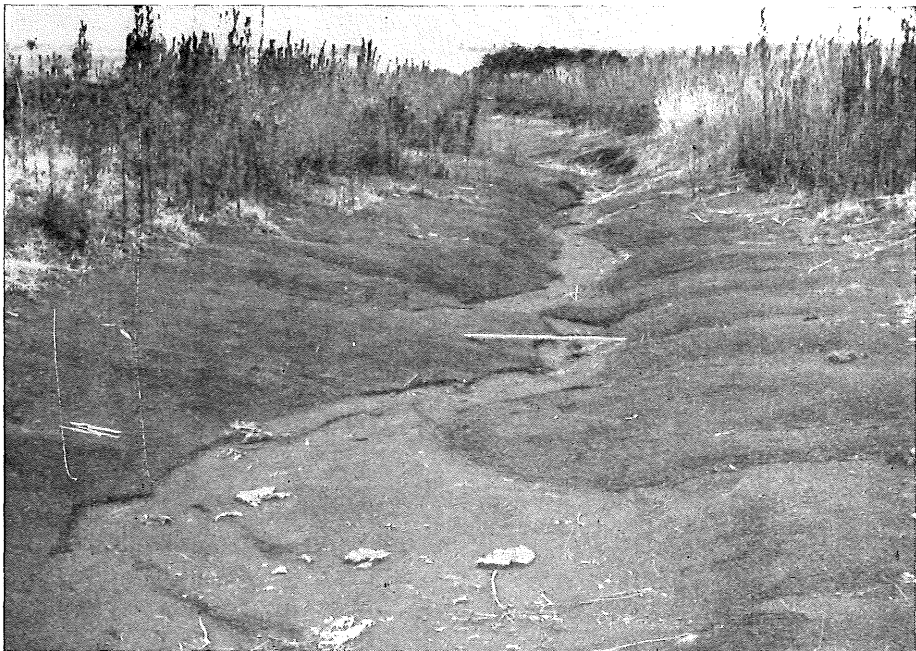
Fig. 10.—Grass was not planted in this scrub soil waterway nor has self-sown grass appeared. The centre gully is up to 2½ ft deep. Waterway 8 in Table 2.

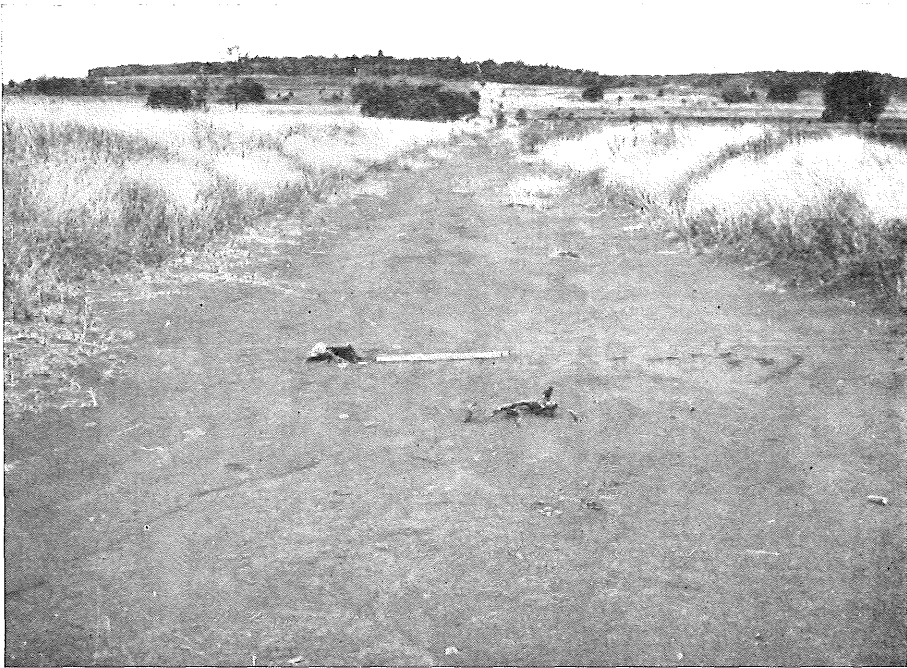
Fig. 11.—Exposed stump roots show gradual loss of soil in a forest soil waterway. Rhodes grass is colonizing slowly in this soil type. The waterway is  $2\frac{1}{2}$  years old. Waterway 16 in Table 3.

In the case of the five forest soil waterways where less than 50 per cent. of the bottom was covered by grass, lack of suitable grass on the banks accounts for two and overgrazing for one. There is no obvious reason why grass is not better established in the other two waterways and one waterway shows clear indication that Rhodes grass is making only slow progress towards colonization (Figure 11).

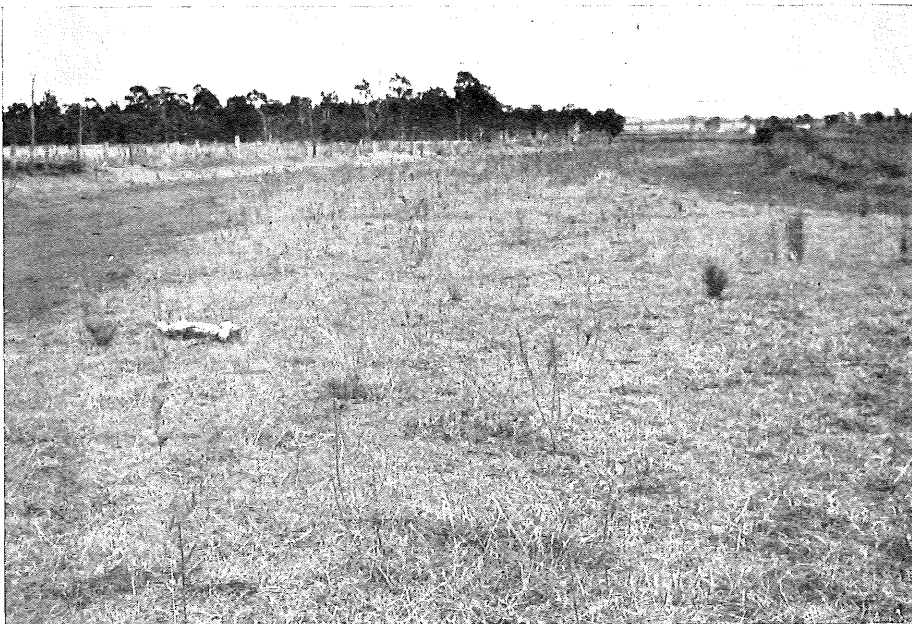
Fig. 12.—A wide forest soil waterway catering for run-off from a 1,500 ac. catchment. Excavation is confined to a strip 25 ft wide on each "side." Waterway 13 in Table 3.

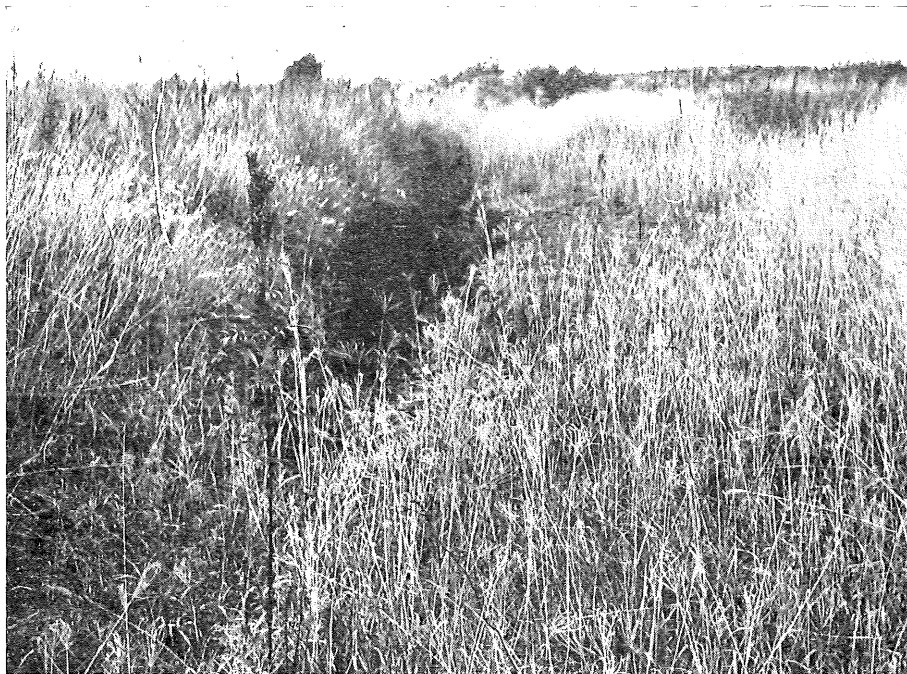
Fig. 13.—Of the 31 waterways inspected, this waterway showed the most serious gully development, including a gully 4 ft deep. Predominance of gravel in the profile suggests that the soil type was atypical and unsuited to the bare soil method. Waterway 25 in Table 2.

Of the remaining five waterways which have rills over 1 ft deep and less than 80 per cent. grass, three (two scrub and one forest) were not planted and even now have large areas on the banks with no suitable grass. One is overgrazed. One has a soil profile showing a considerable amount of gravel and should not be regarded as typical red scrub soil.
