**An Investigation of the Impacts of Poned Pastures
on Barramundi and Other Finfish Populations
in Tropical Coastal Wetlands**

Final Report

Project No. 97/201

Department of Primary Industries, Queensland 2002

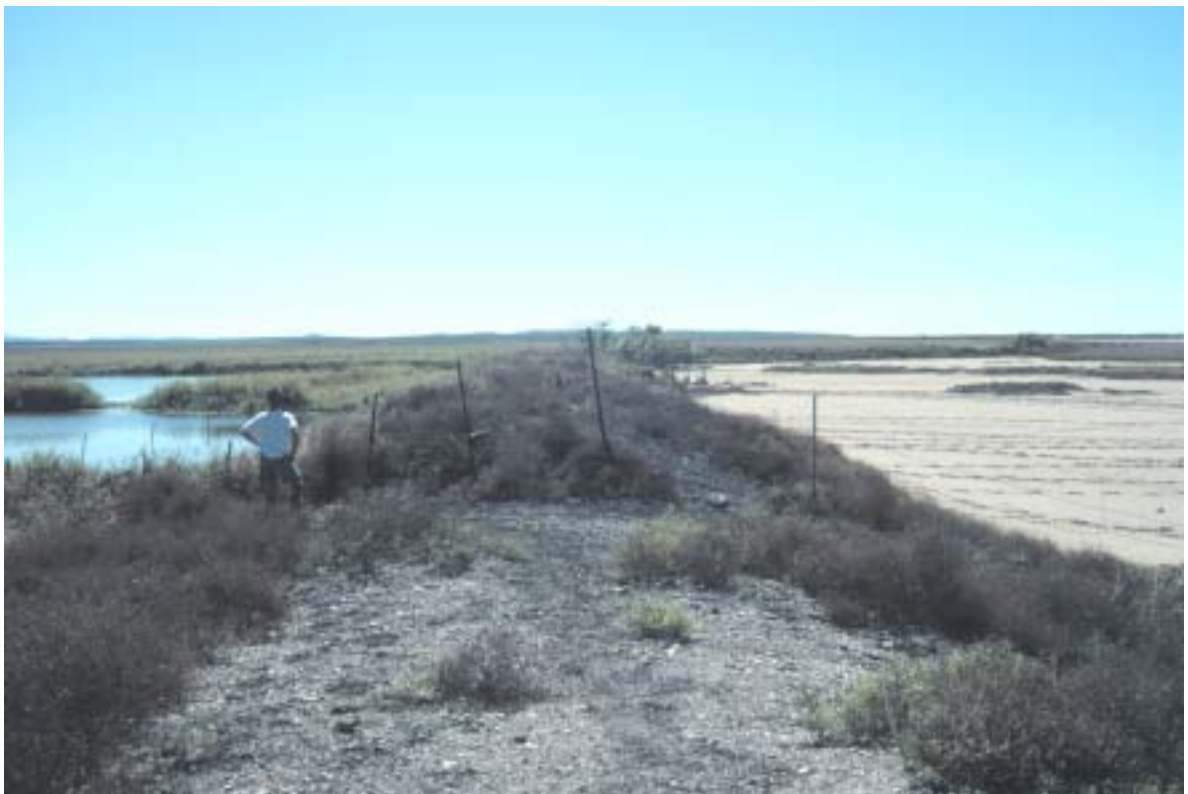
Pondage bank at Broad Sound

This bank is some 9 km long, 2 m wide, and ranges in height from around 1 m to more than 2 m except for a number of low points (referred to as bywashes) that are level with the adjacent terrain. These bywashes direct overflow to the estuary downstream of the bank and effectively provide for a flow through the pondage system before the system is fully inundated. The bank has been constructed across the estuarine-freshwater interface of a small coastal stream that flows into a tidal section of a larger coastal stream. There is evidence of active erosion processes in the deep tidal gutters immediately downstream of the bank. A similar pondage bank is located nearby across a similar estuarine-freshwater interface associated with another small coastal stream. This system is subject to tidal intrusion around one end of the bank. The tidal intrusion has encroached into areas previously covered with pasture with a resulting decrease in pasture cover.

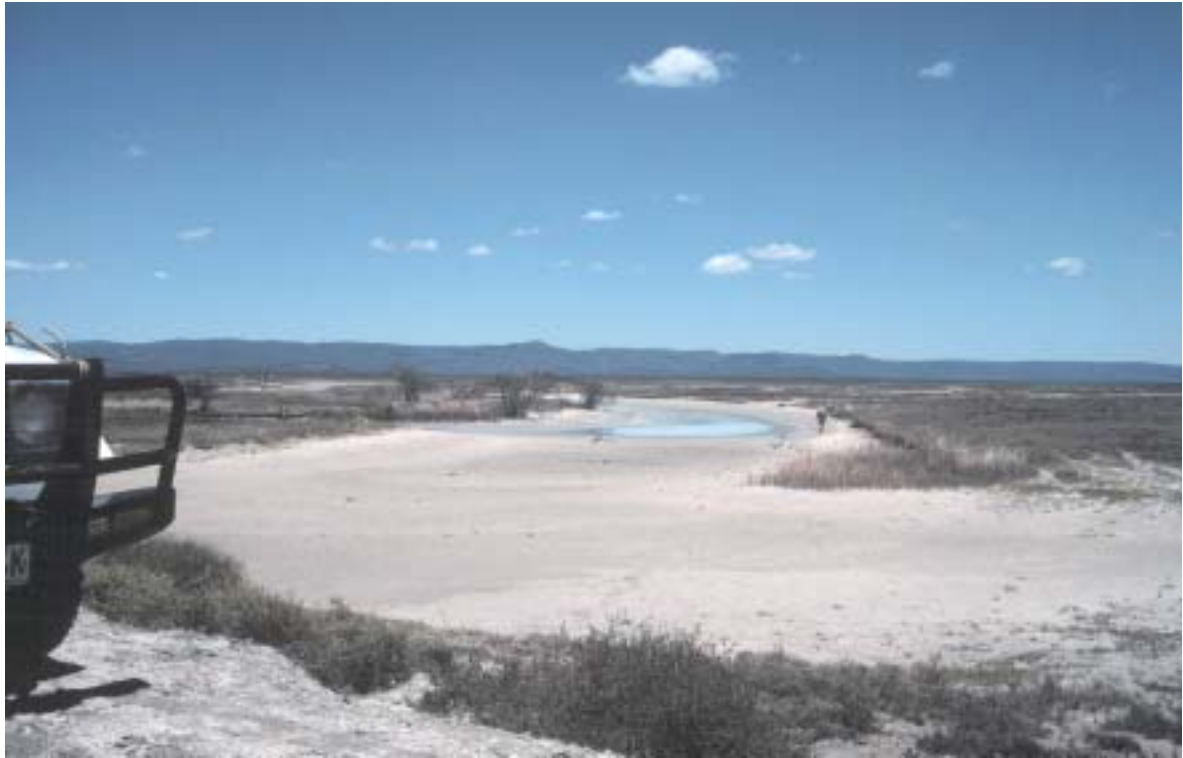
Pondage system at Broad Sound during dry phase showing remnant tidal channel (isolated from tidal inundation).

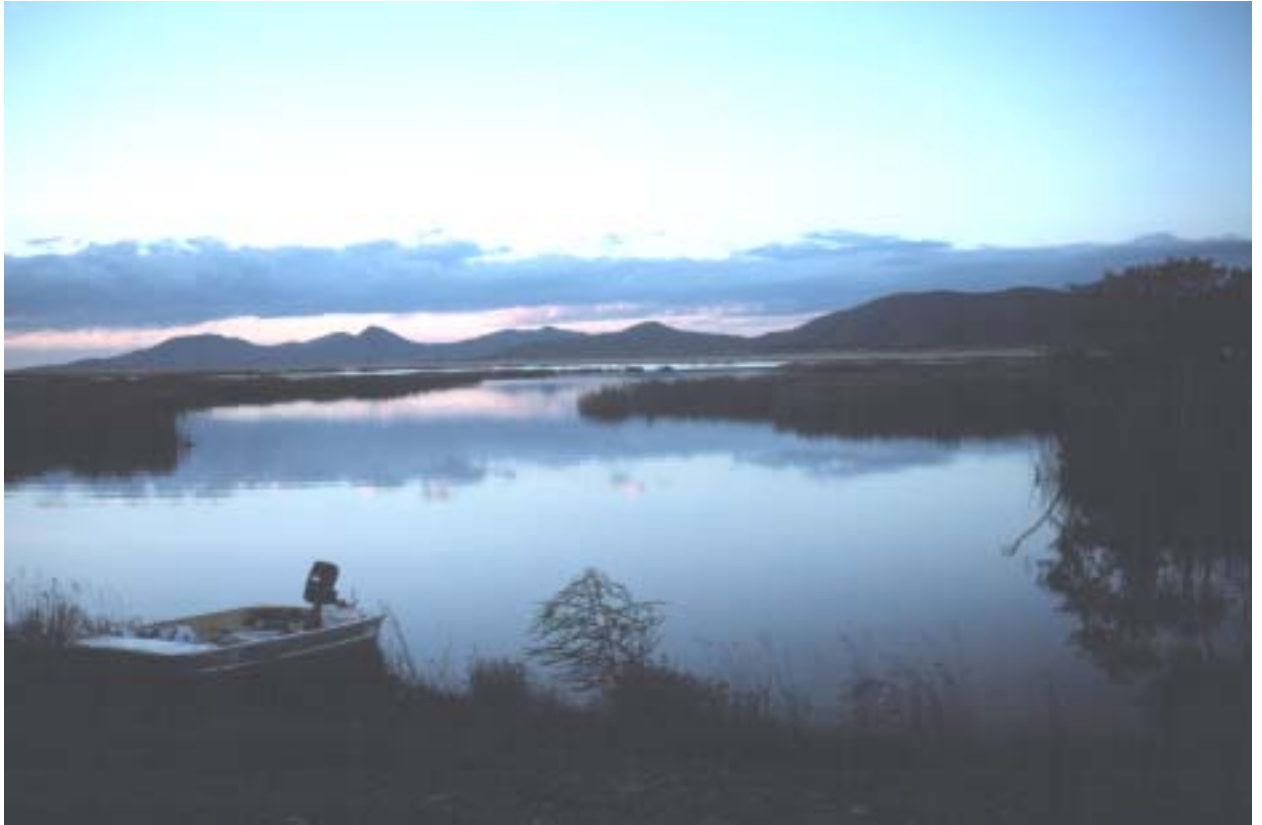
Pondage system formed by blocking of tidal channel at Fitzroy location.

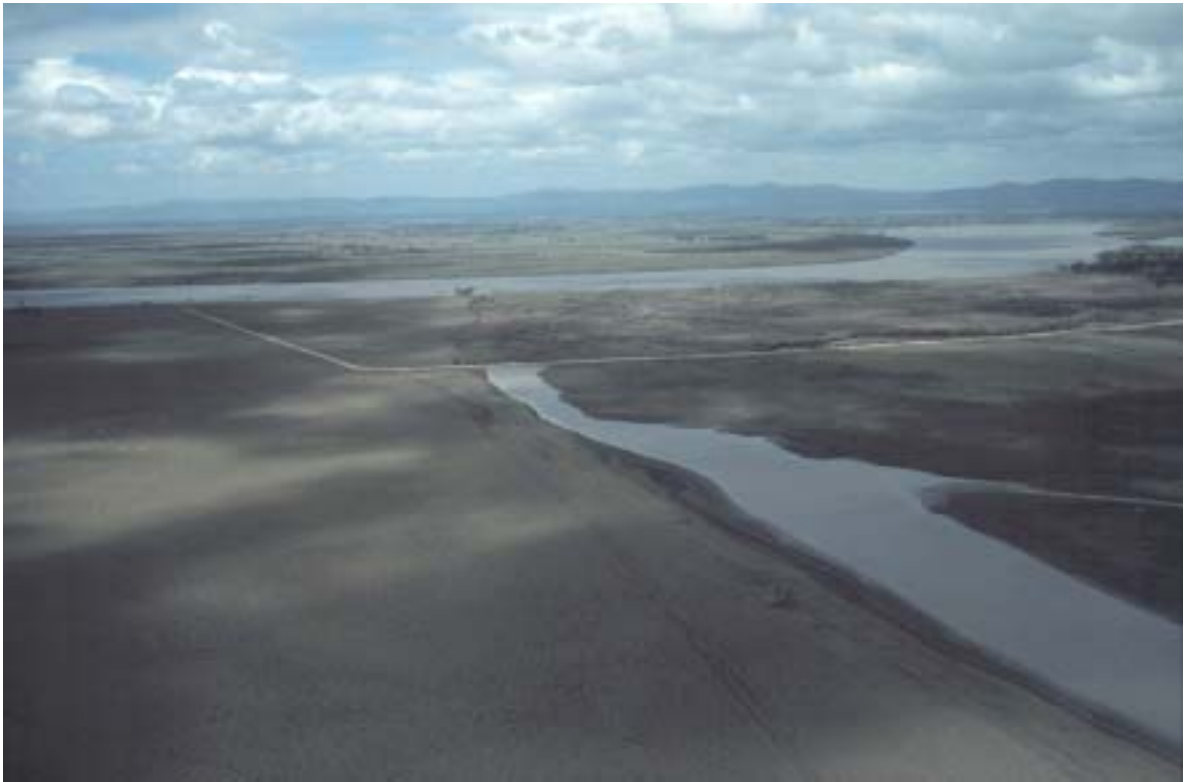
Section of pondage system adjacent to Fitzroy River showing remnant tidal channel isolated from estuary.

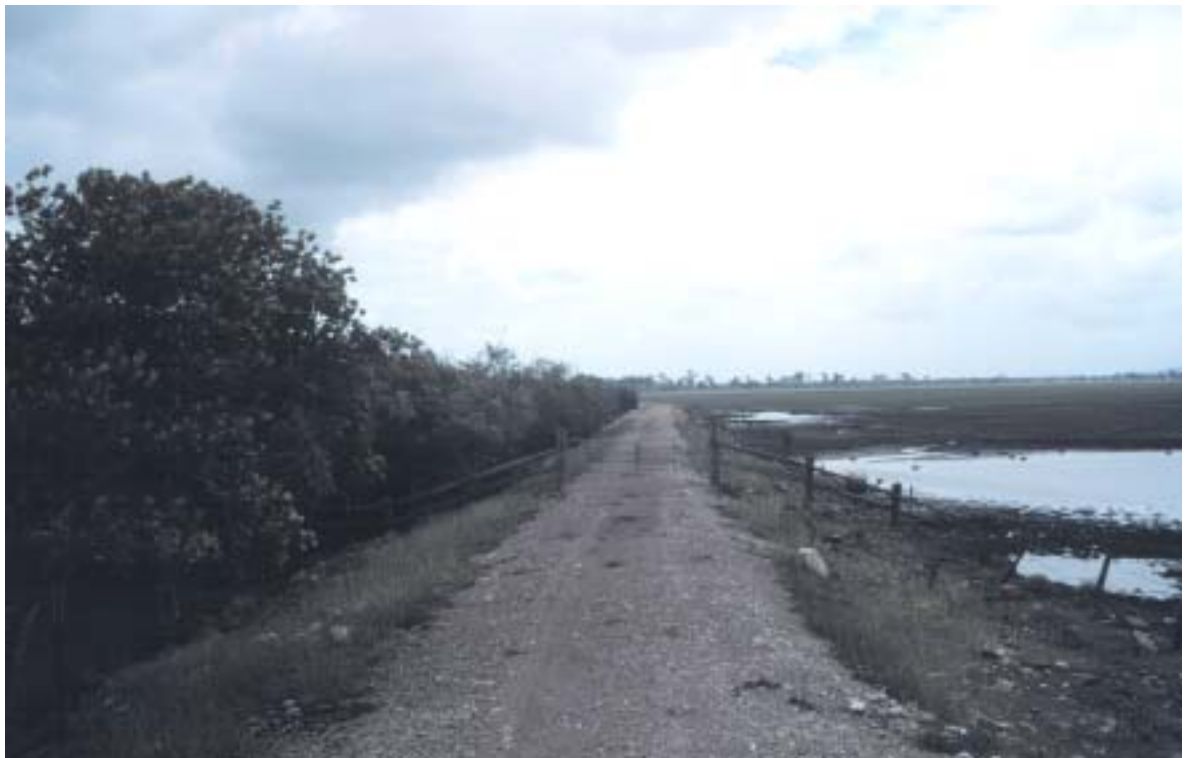
Mangrove growth along pondage bank adjacent to Fitzroy River.

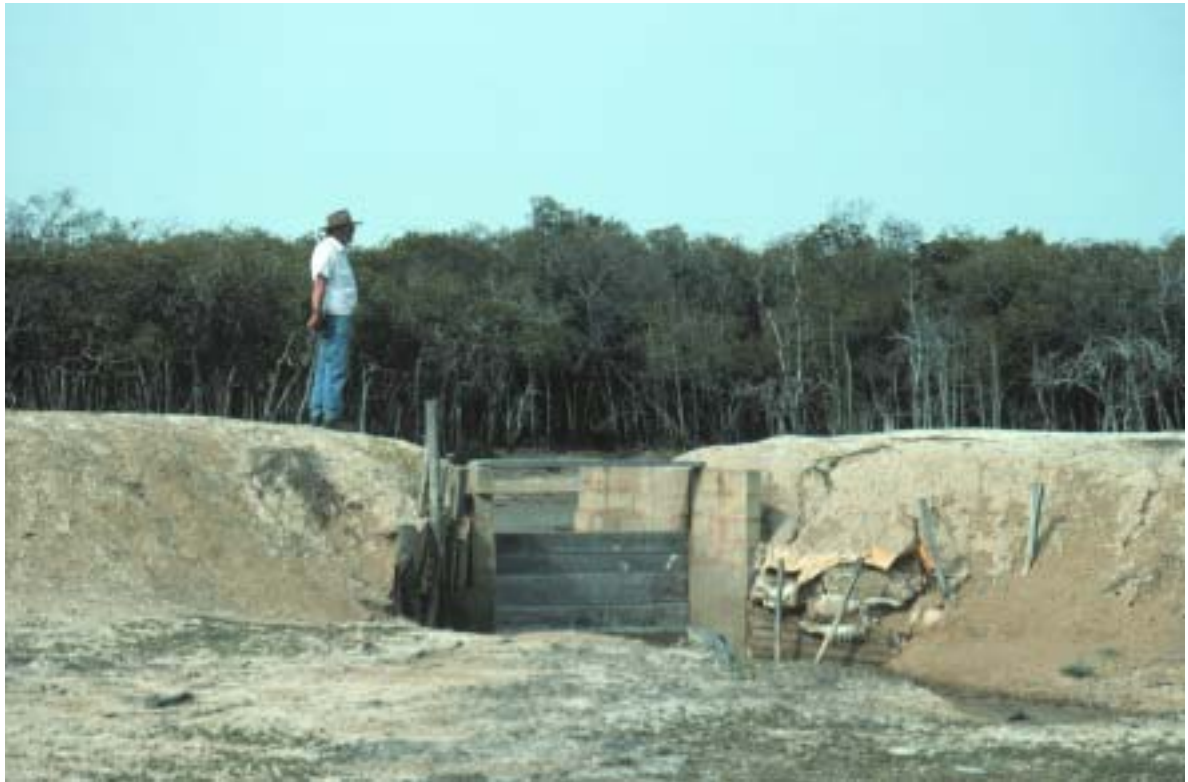
Pondage bank with sluice gate adjacent to mangroves, Broad Sound.

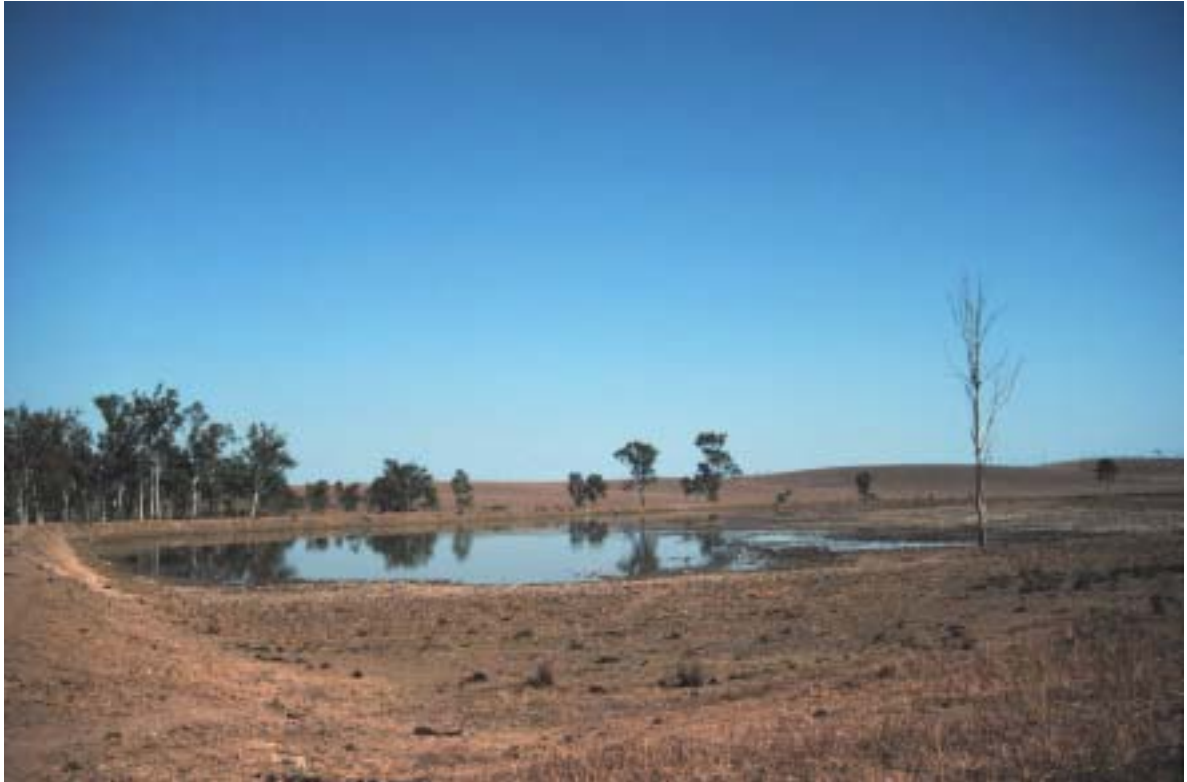
Pondage system across drainage line on hill side in southern Fitzroy delta.

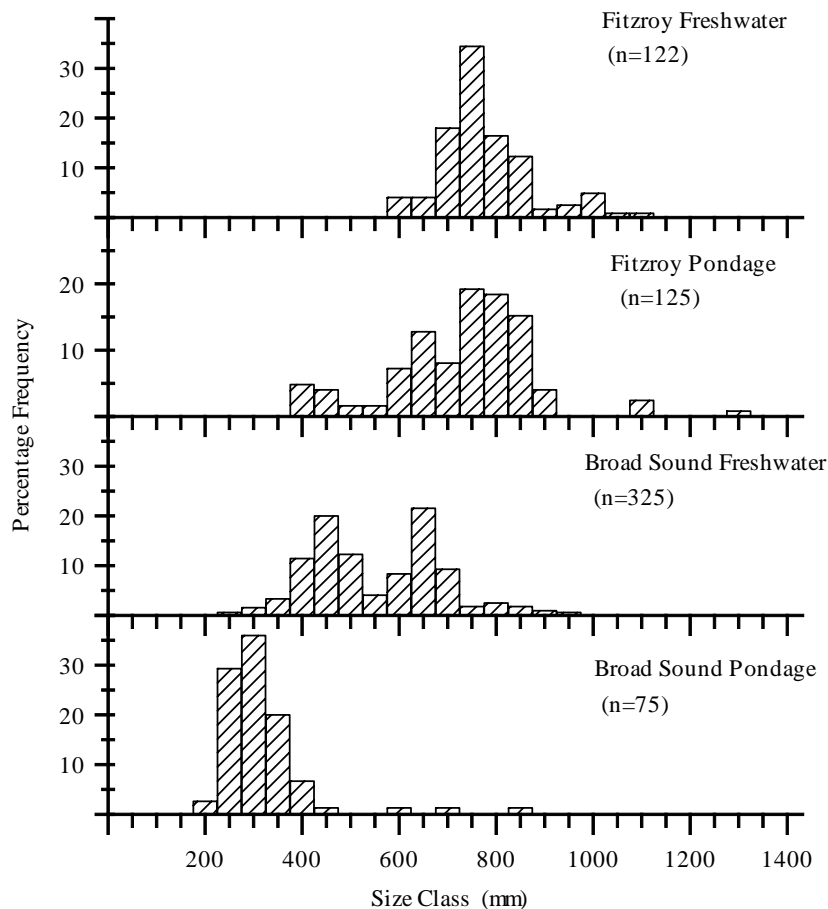
Figure 10 Size frequency of barramundi from Fitzroy and Broad Sound locations by habitat type.

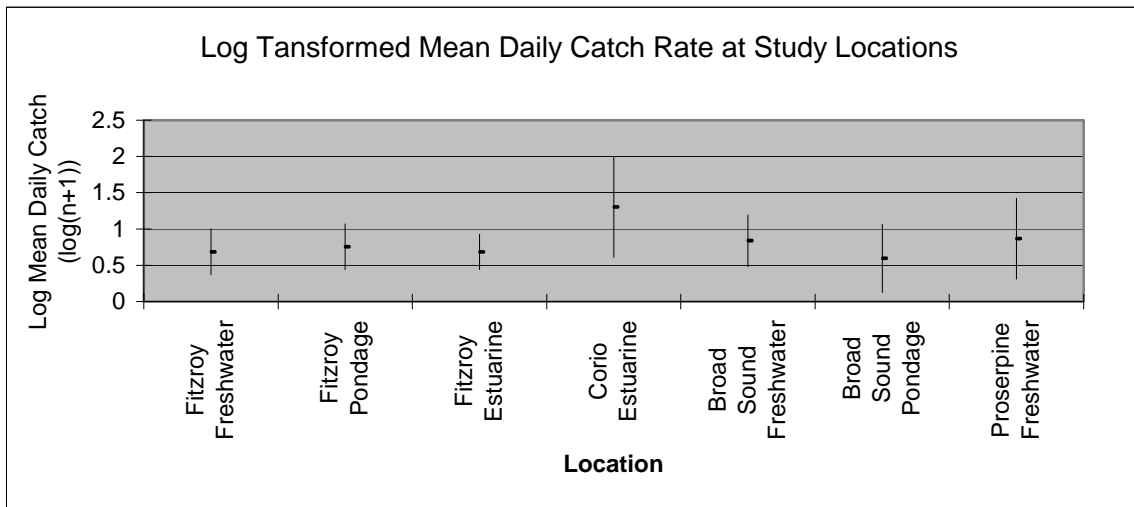
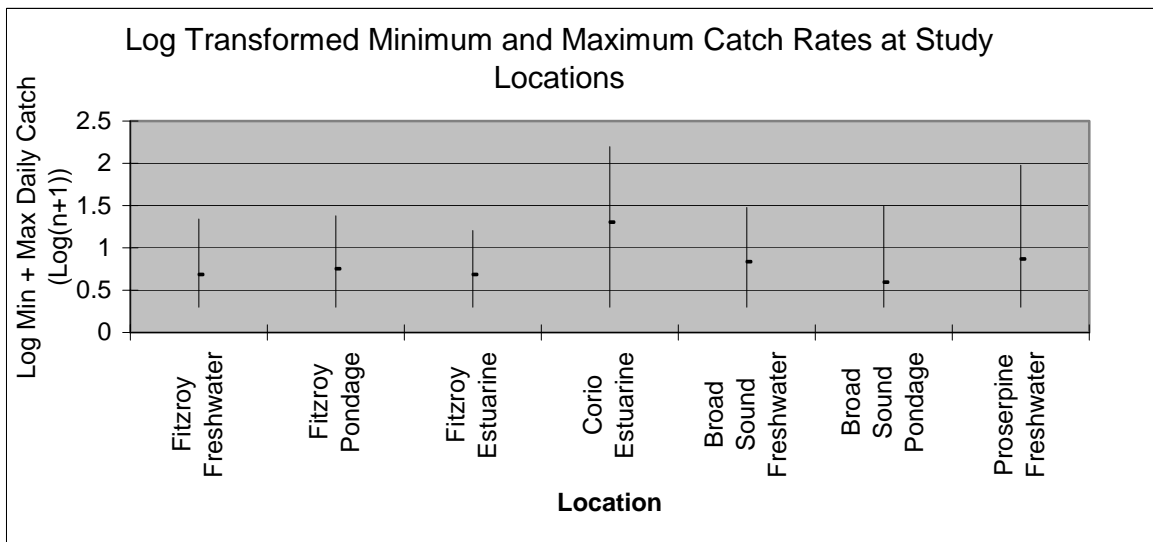
Figure 13 Log transformed barramundi catch rates by location.

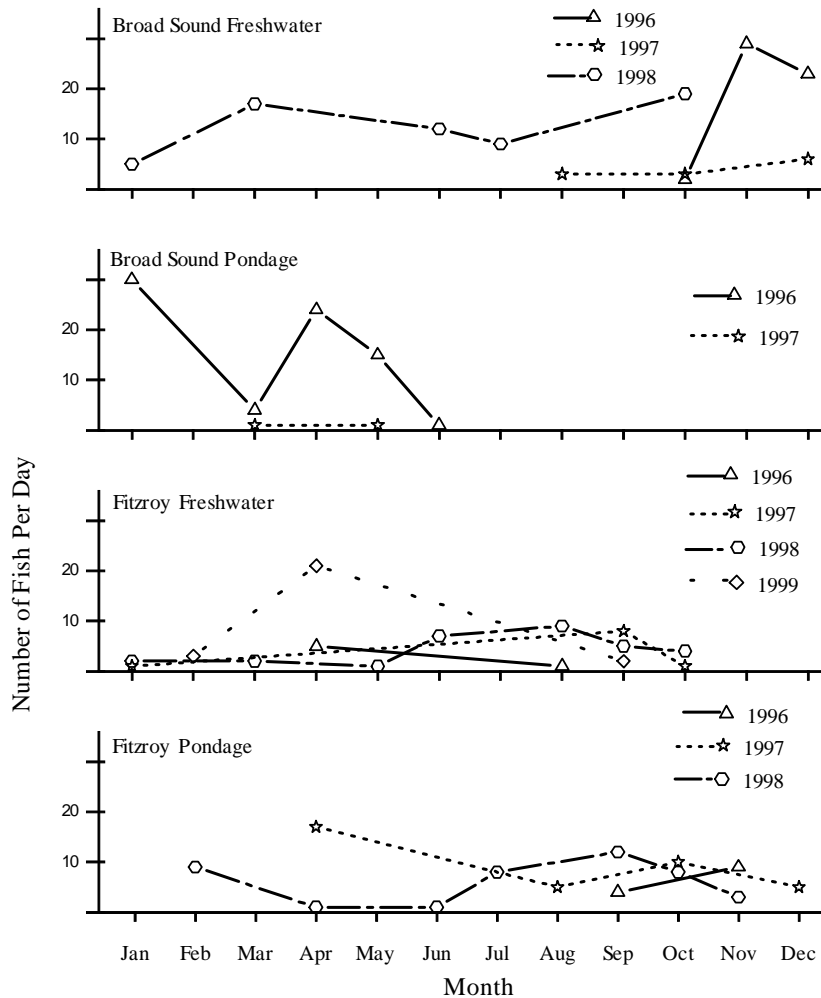
Figure 14 Monthly catch per day of barramundi.

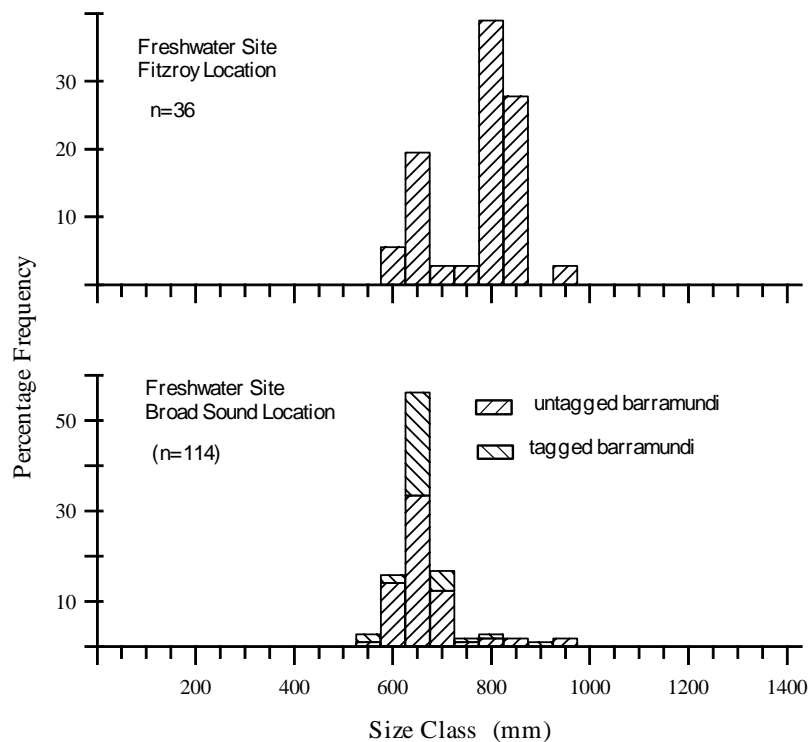
Figure 15 Size frequency of barramundi in mass kills.

Thirty-eight tagged barramundi were recovered from the kill and 112 of the dead barramundi were measured. Barramundi ranged in size from 530 mm to 870 mm. Size frequency of tagged and untagged barramundi in this kill were similar (Figure 15). The mass kill appeared to have included all barramundi at the site since subsequent sampling failed to capture any barramundi. All the dead barramundi that were recovered in the kill were extremely bloated and were found floating at the surface. One live barramundi was also found at the surface and this animal displayed very weak uncoordinated movements and did not survive long after handling. There were no barramundi collected from below the surface or from the substrate.

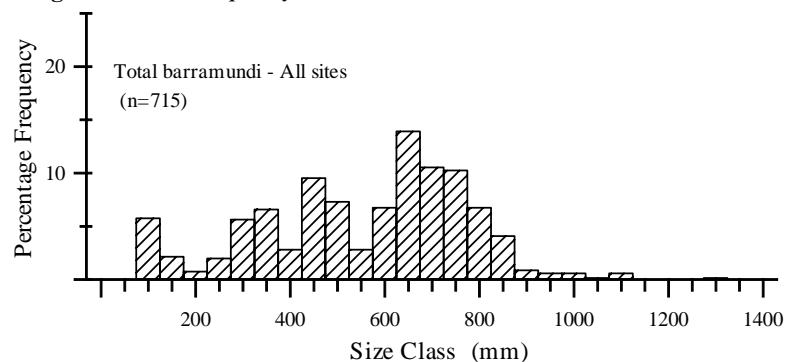
Figure 16 Size frequency of barramundi from all sites and times.

The size frequency of barramundi over all samples (all sites and times) indicates there were up to five cohorts of barramundi at 100, 250, 450, and 650 mm (Figure 16). Seasonal size

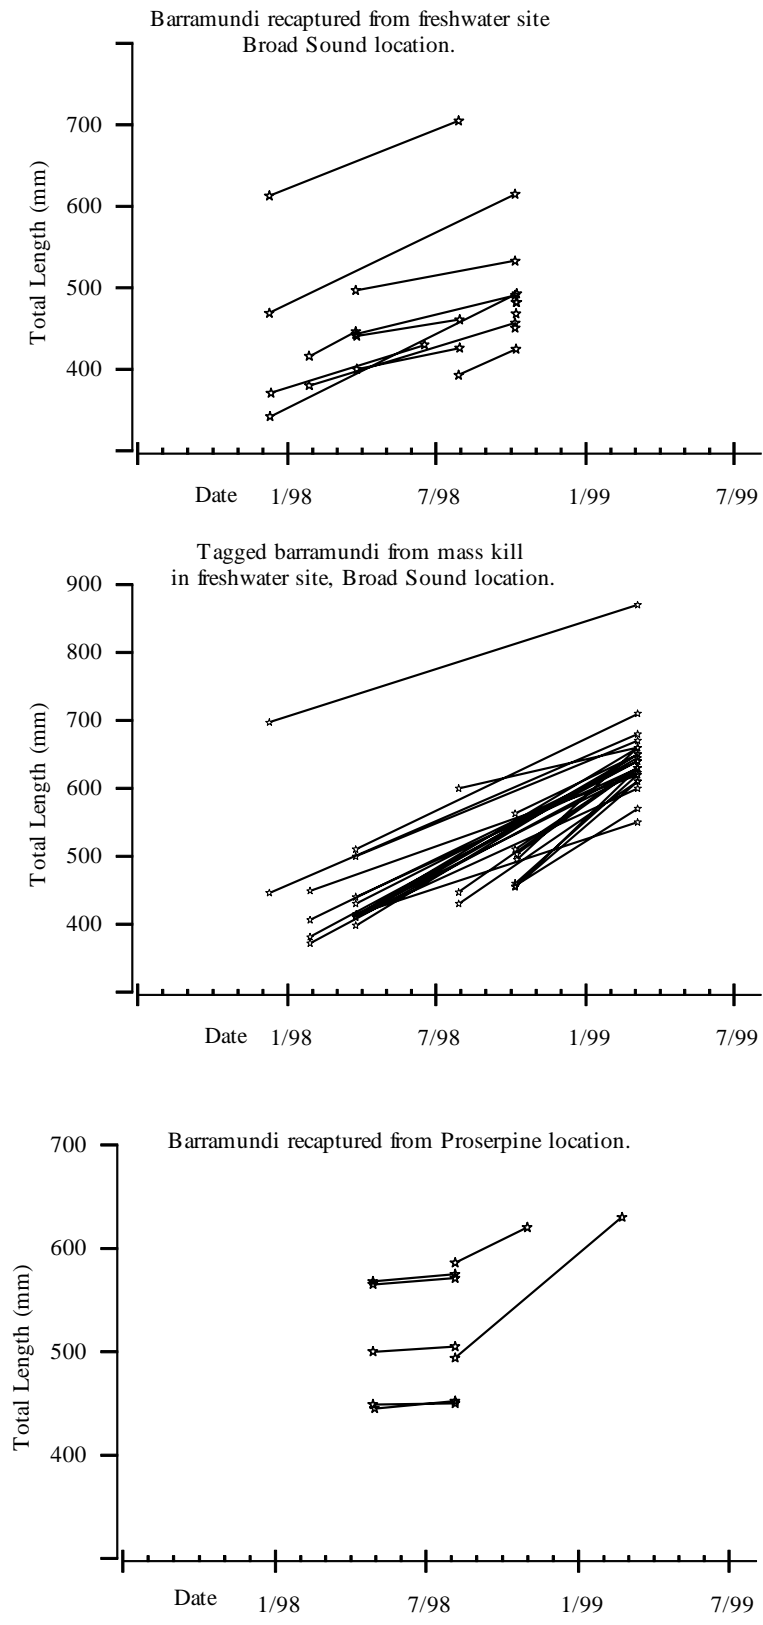
Figure 18 Release and recapture sizes for individual recaptured barramundi at Broad Sound and Proserpine locations. (Each line represents an individual barramundi with the release size indicated by the star at the left side of the line and the recapture size indicated by the star at the right side of the line.)

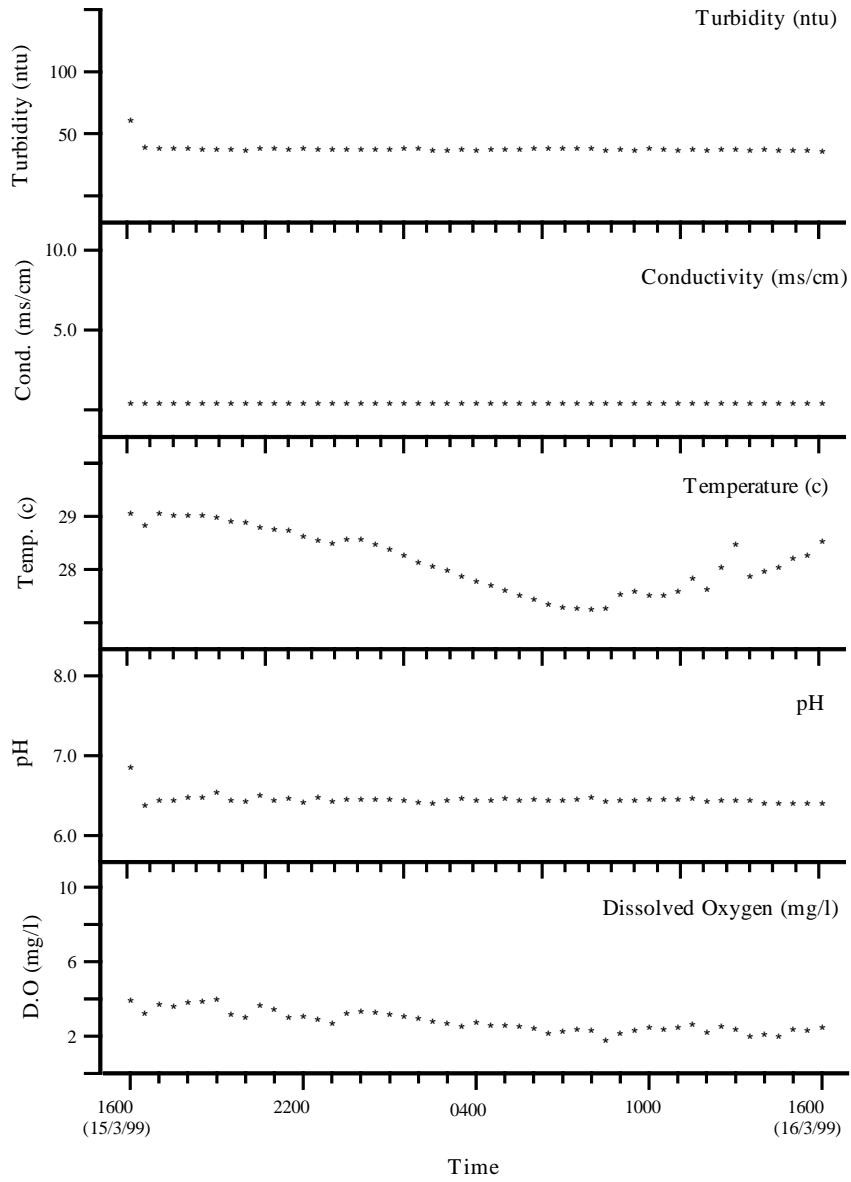
Water Quality Profile, Broad Sound Freshwater Site, March 1999
